PROPERTY CONDITION REPORT

Marin Valley Mobile Country Club

100 Marin Valley Drive
Novato, California 94949

June 10, 2025

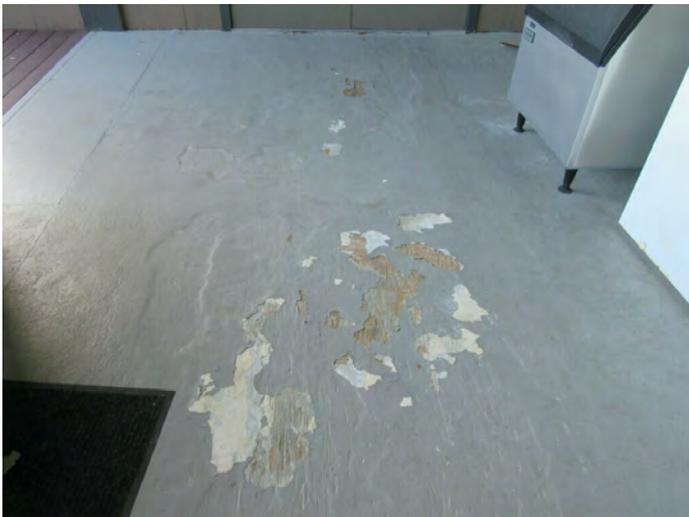
4.5	The elastomeric coating on the surface of the balconies were observed to be in poor condition. Prepping and re-applying elastomeric coatings on the balconies is required at this time.	5,000	SF	\$1.25	\$6,250		\$6,250

75. Failing elastomeric traffic coating on the upper deck of the clubhouse.

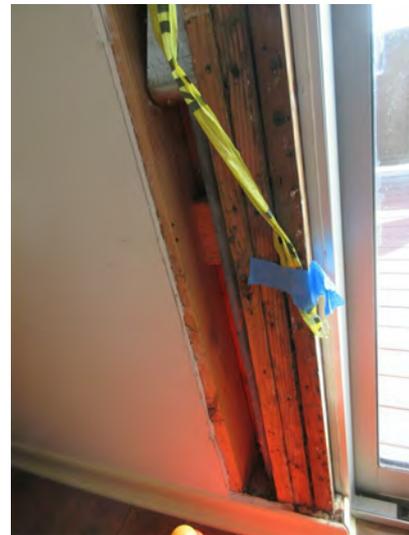
4.2	Management reported there was termite infestation in the east wall of the card room on the lower floor under the ballroom area of the clubhouse building. A portion of the gypsum wallboard (GWB) sheathing had been removed on the left, west, side of the sliding glass door exposing some of the damaged framing. Additional, possibly destructive, investigation to determine the extent of the termite infestation is recommended at this time. Remediation of the infestation is recommended to prevent additional structural damage to the clubhouse structure.	1	ALLOW	\$47,950	\$47,950		\$47,950

76. Exposed termite damage on the east wall of the lower level of the clubhouse.

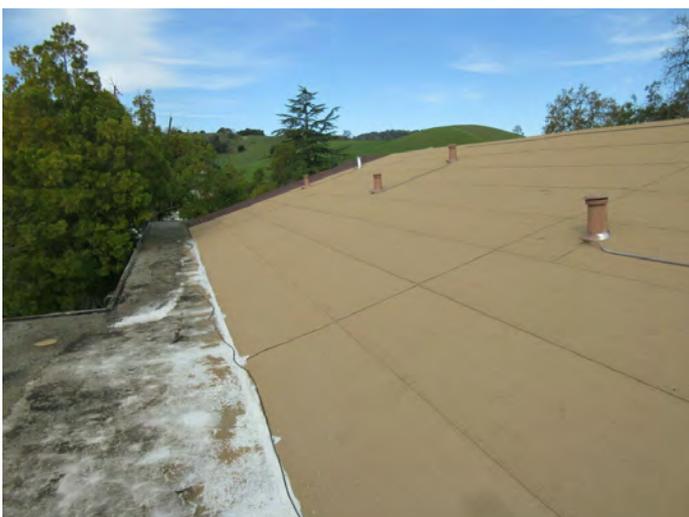
77. Large roof patch over asphalt composition shingles (ACS) on the clubhouse roof.

4.4.1	The removal and replacement of the BUR roofing system at the clubhouse buildings is recommended at this time.	4,000	SF	\$12	\$48,000		\$48,000
4.4.1	The removal and replacement of the ACS roofing system at the clubhouse buildings is recommended at this time.	9,000	SF	\$9.00	\$81,000		\$81,000

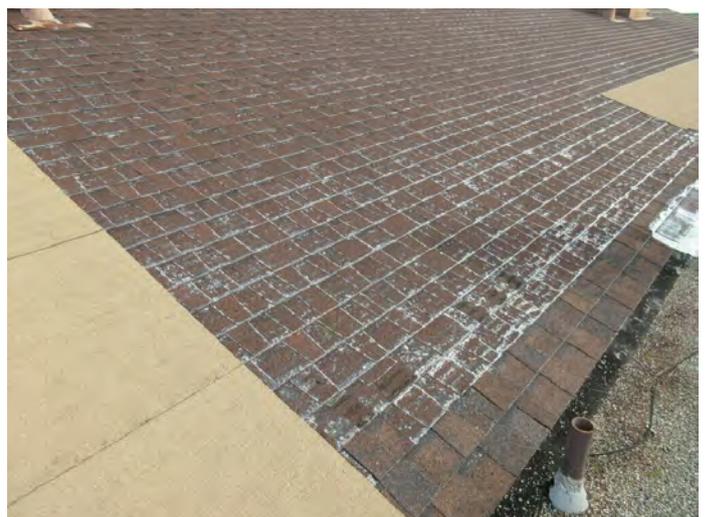
78. The ACS roofing on the clubhouse requires replacement at this time.

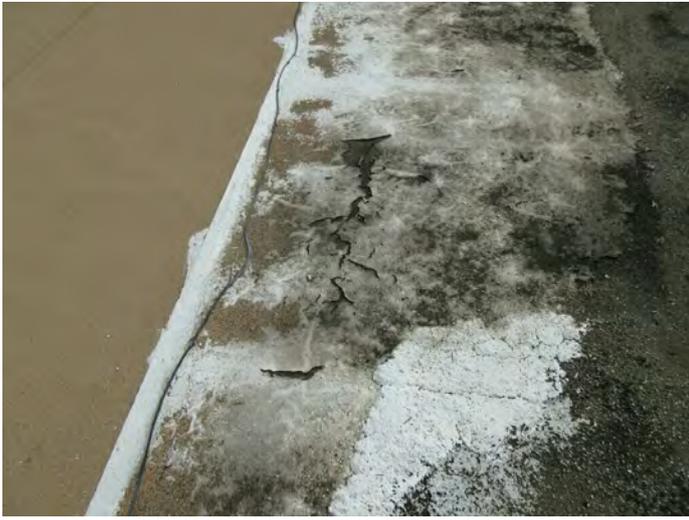
79. Failing BUR roofing on the clubhouse.

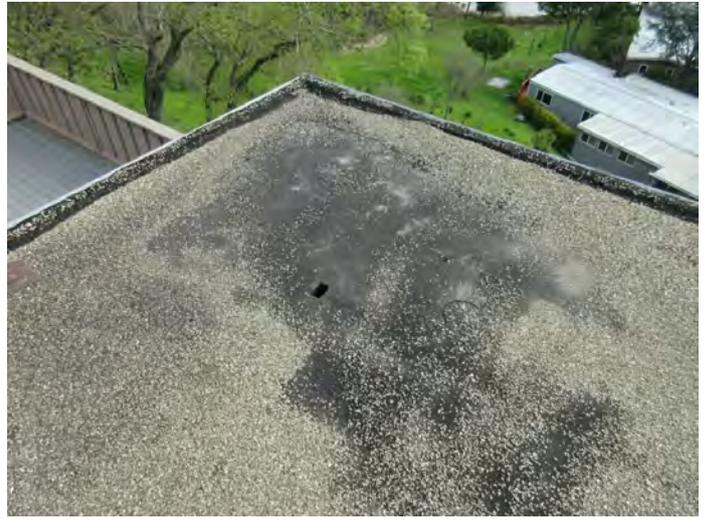
4.4.2	Evidence of ponding was observed at the flat roof areas of the clubhouse. The flat roof areas at the clubhouse had no positive slope for proper roof drainage. The installation of positive slope to roof drain/overflow assemblies in the flat roof areas should be conducted during the roof replacement activities..	1	ALLOW	\$50,000	\$50,000		\$50,000

80. Roof drain opening on the clubhouse roof.

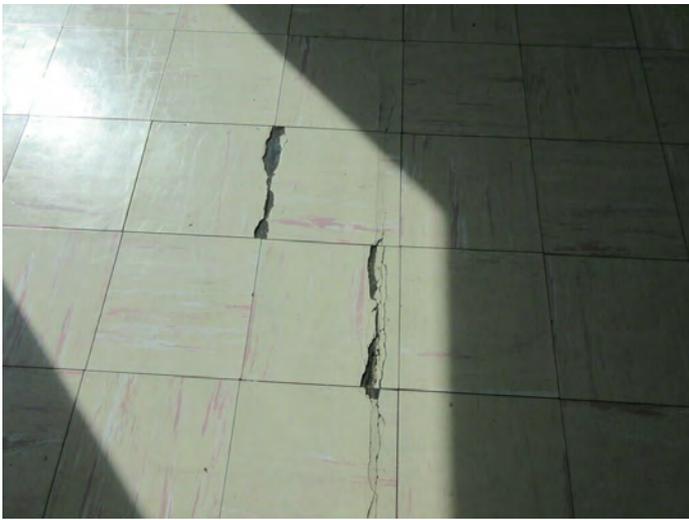
81. Damaged flooring at the east side of the ballroom.

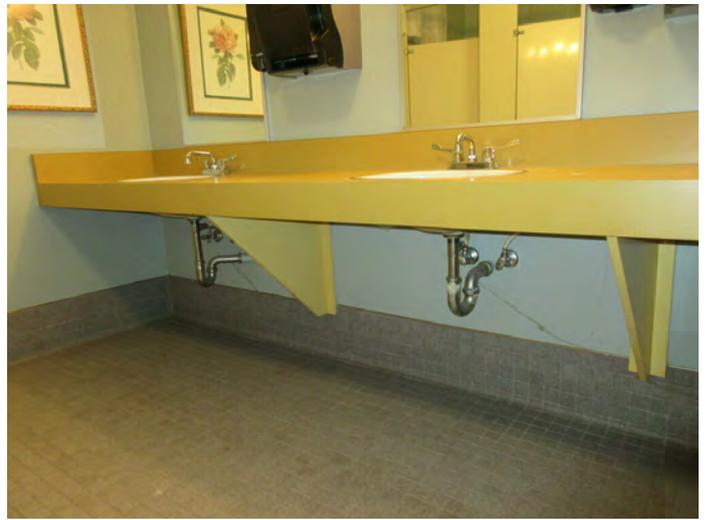
82. Exposed sink drain plumbing in the common women's room of the clubhouse

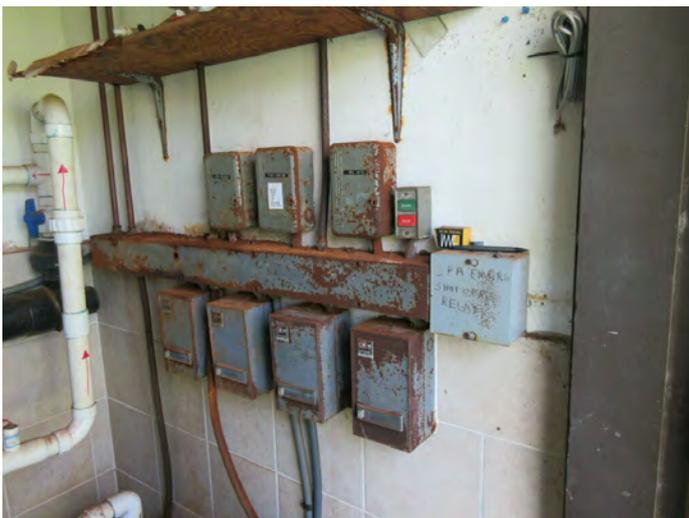
83. Rusted electrical panels and switches in the swimming pool equipment room.

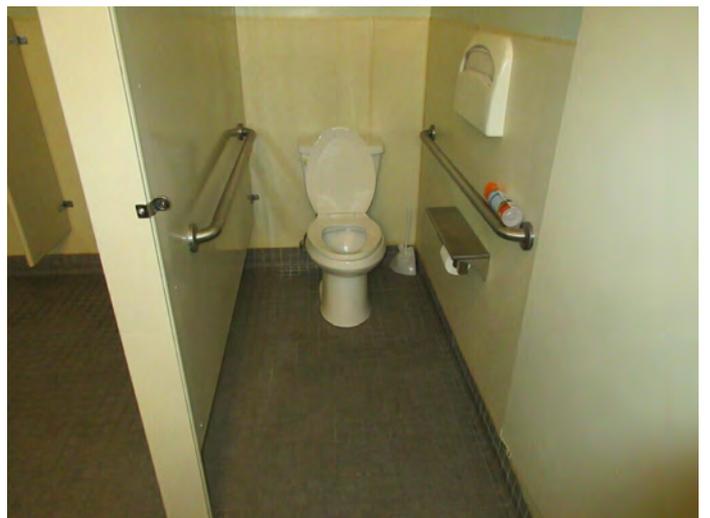
84. The accessible toilet stall in the common men's room in the clubhouse does not meet ADAAG requirements.

7.0	ACCESSIBILITY						
7.0	Conduct as-needed ADA improvement to the community building restrooms.	1	ALLOW	\$35,750	\$35,750		\$35,750
8.0	WATER INTRUSION AND MICROBIAL GROWTH						
	None Noted						
TOTALS					\$479,950	\$0	\$479,950
