PROPERTY CONDITION REPORT

Marin Valley Mobile Country Club

100 Marin Valley Drive
Novato, California 94949

June 10, 2025

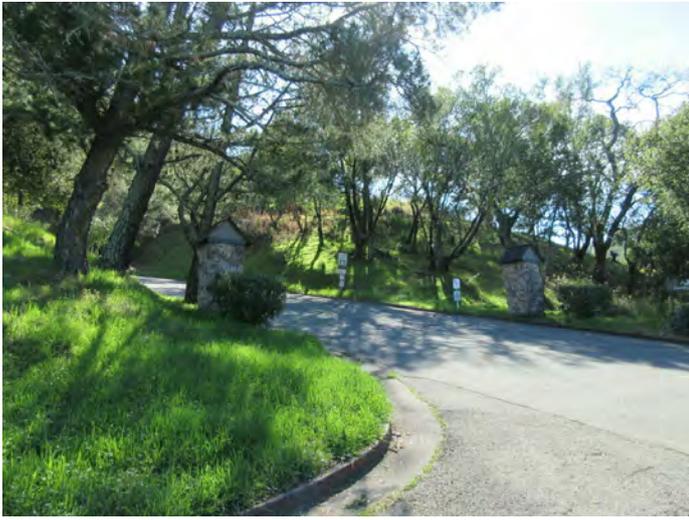
1. Entrance to the site from the west.

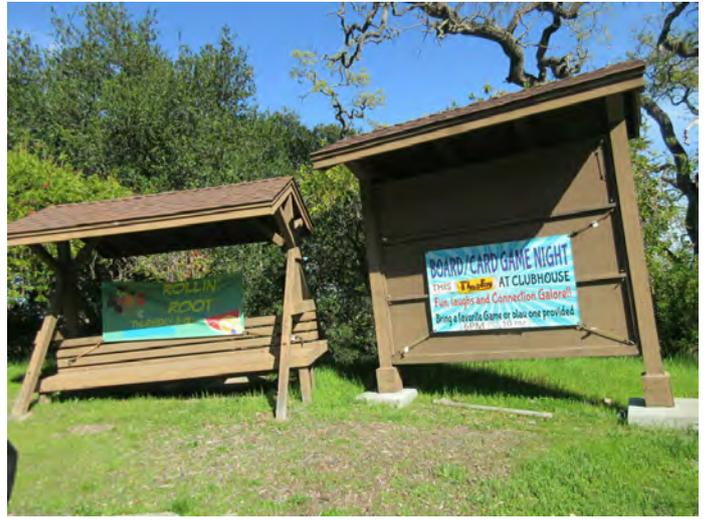
2. Site signage.

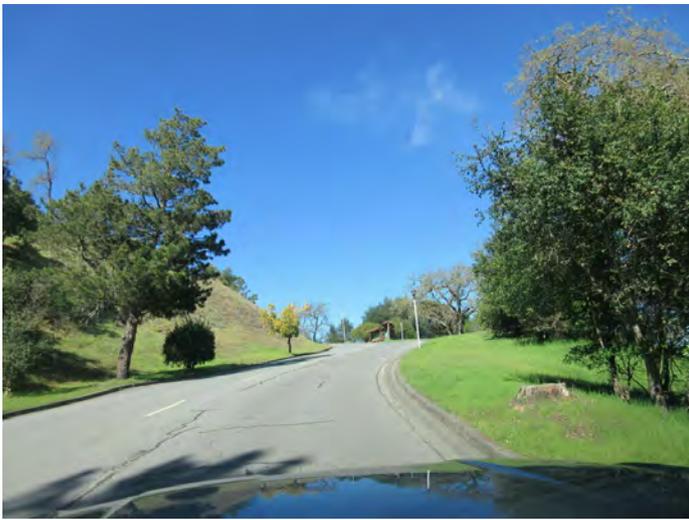
3. Access road to the property.

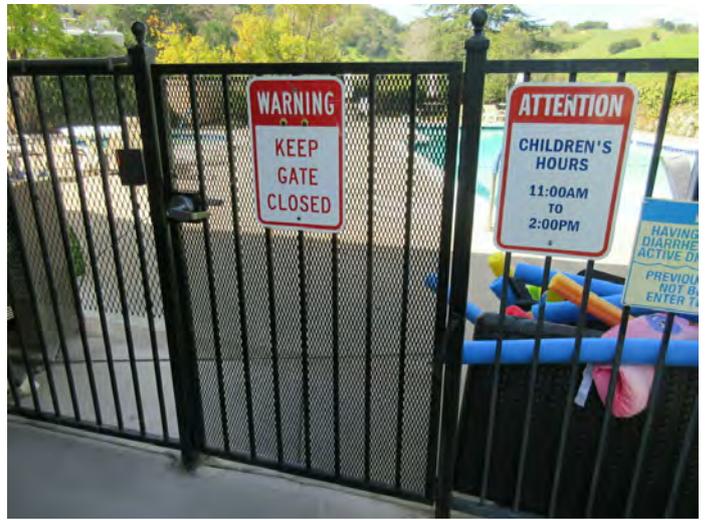
4. Swimming pool enclosure gate.

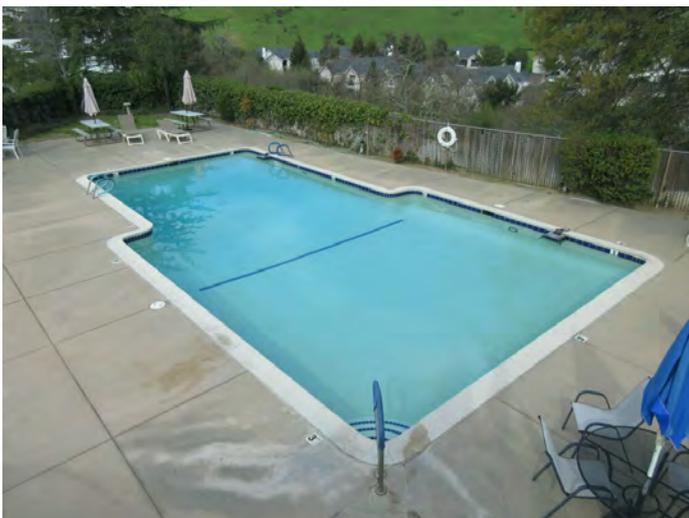
5. Swimming pool looking northwest from the clubhouse roof.

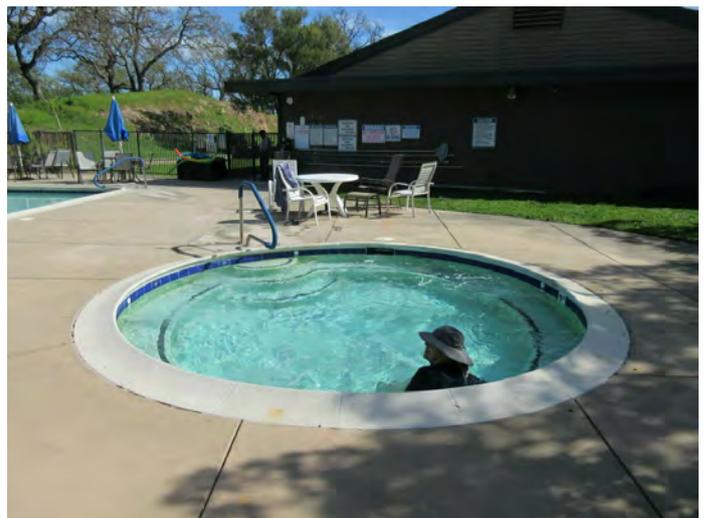
6. Spa.

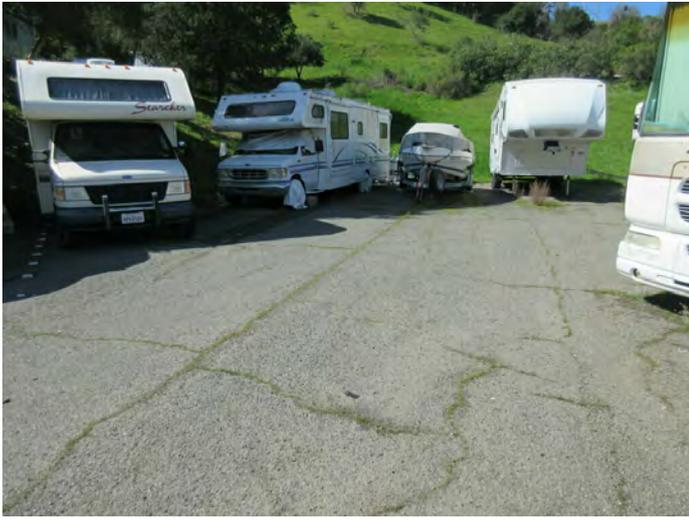
7. RV parking area near the laundry building.

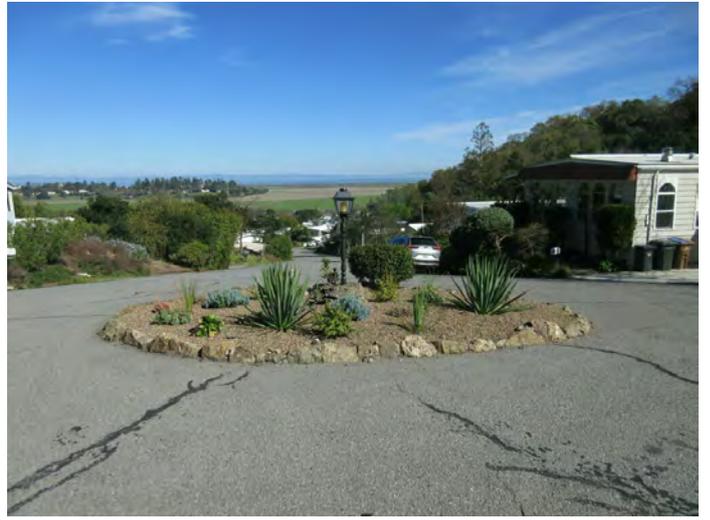
8. Island at the end of an onsite cul-de-sac.

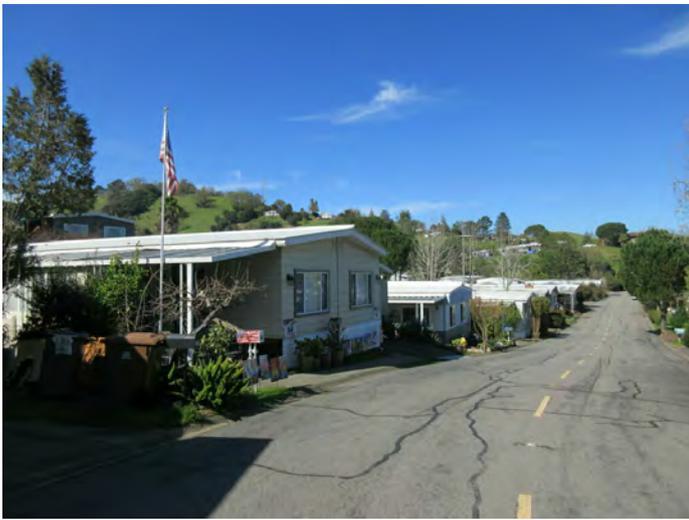
9. View of Club View Drive looking northwest.

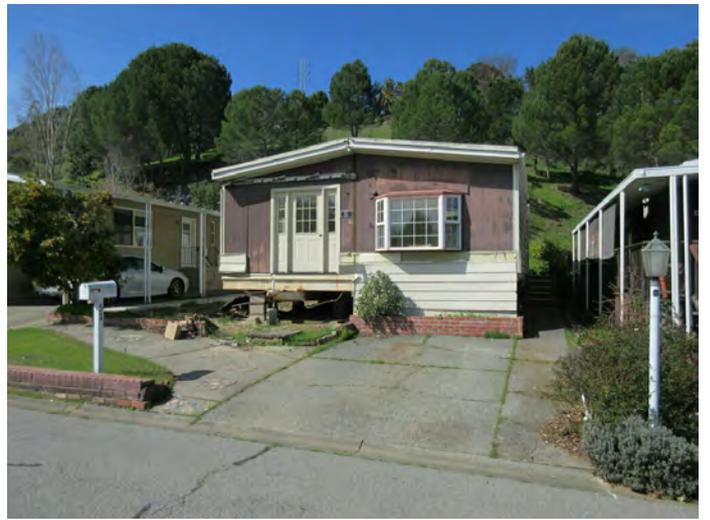
10. A vacant manufactured home was being prepared to be removed.

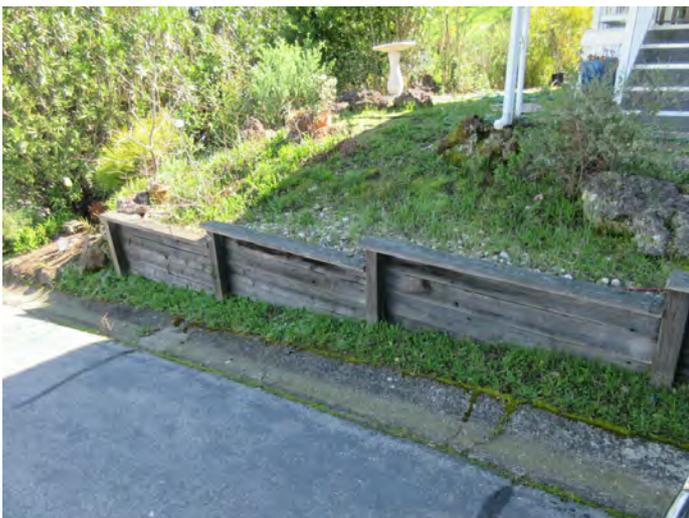
11. Wood retaining wall.

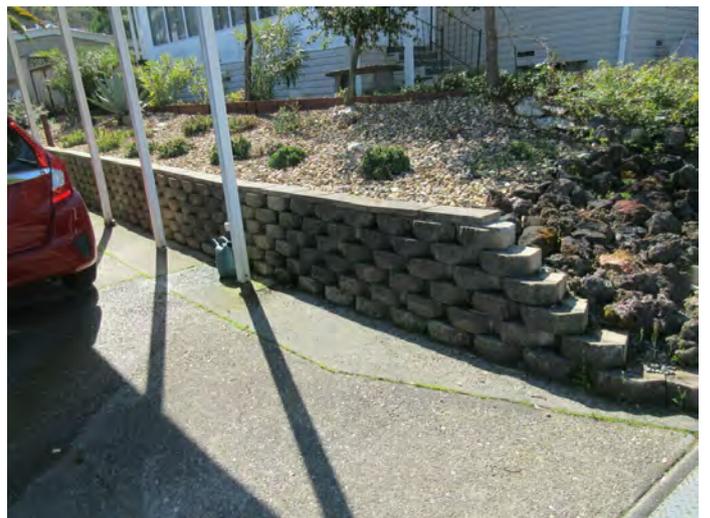
12. Keystone retaining wall.

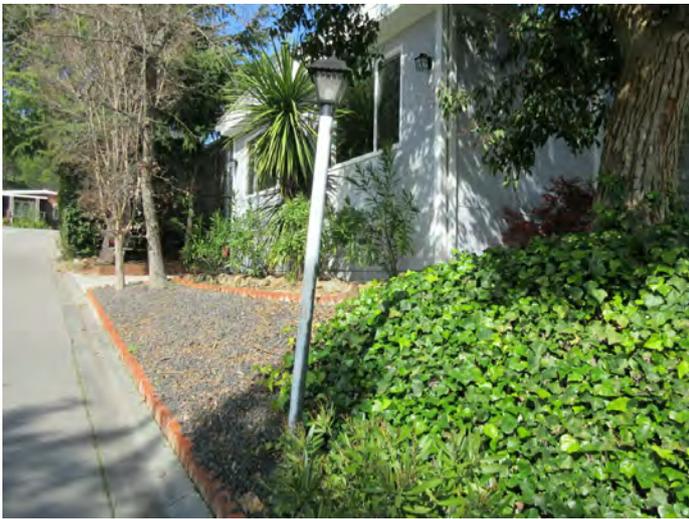
13. Original pole-mounted site lighting fixture.

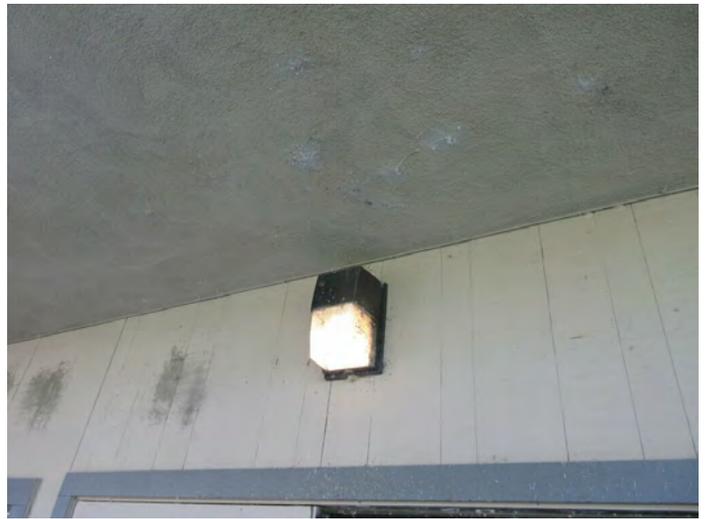
14. Facade-mounted site lighting fixture on the clubhouse.

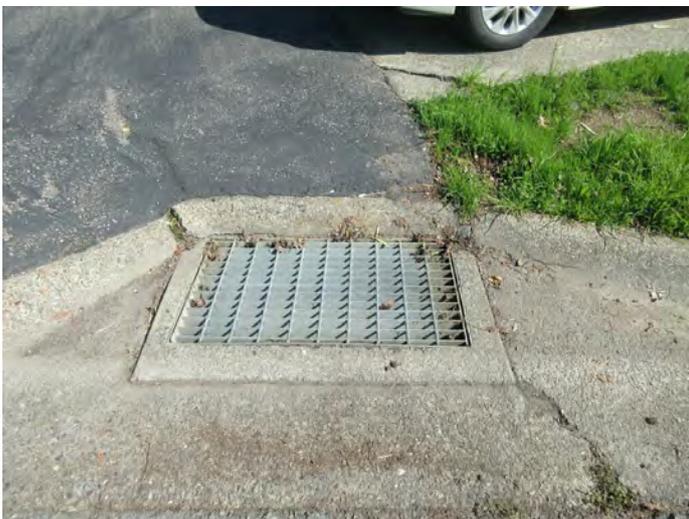
15. Stormwater catch basin.

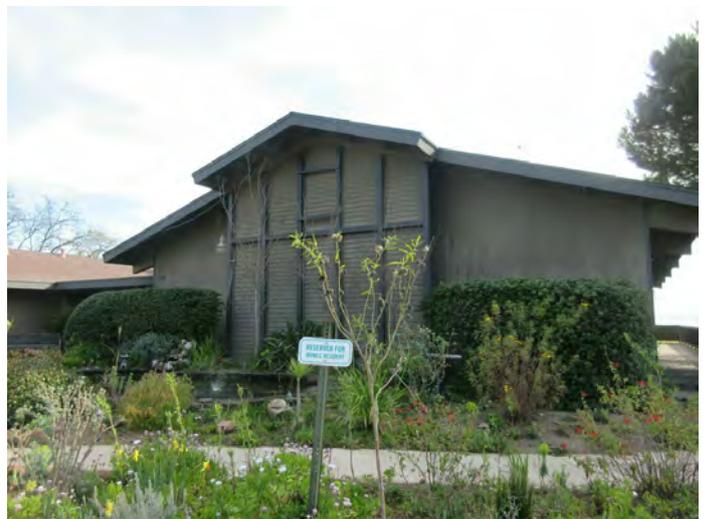
16. Clubhouse looking northeast.

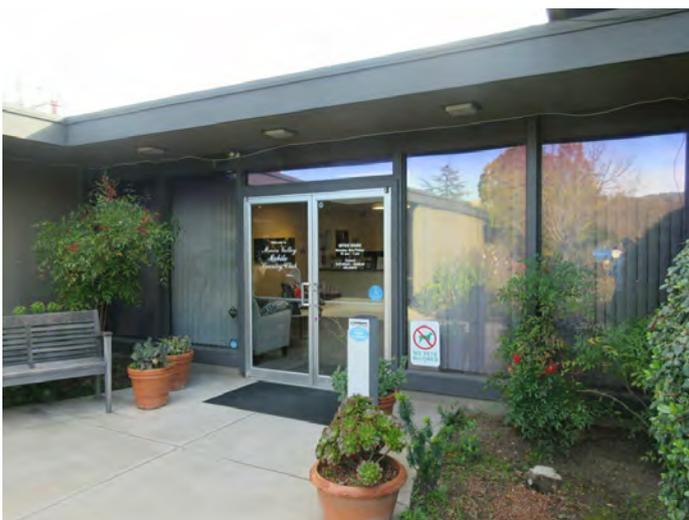
17. Clubhouse entry.

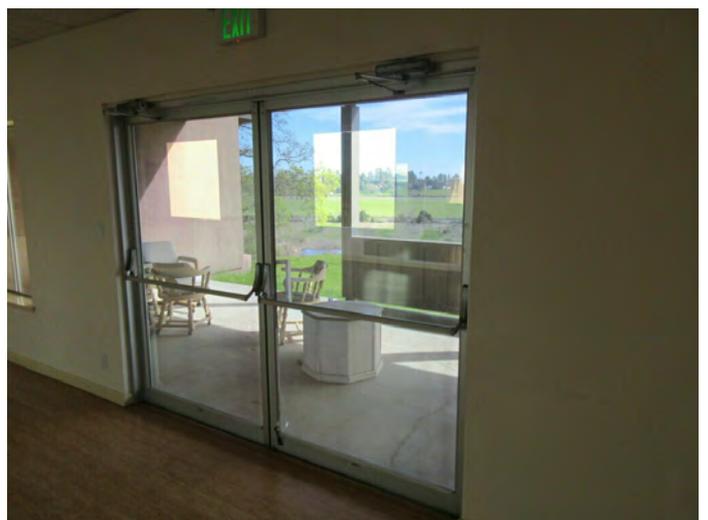
18. Storefront doors in the lower level of the clubhouse.

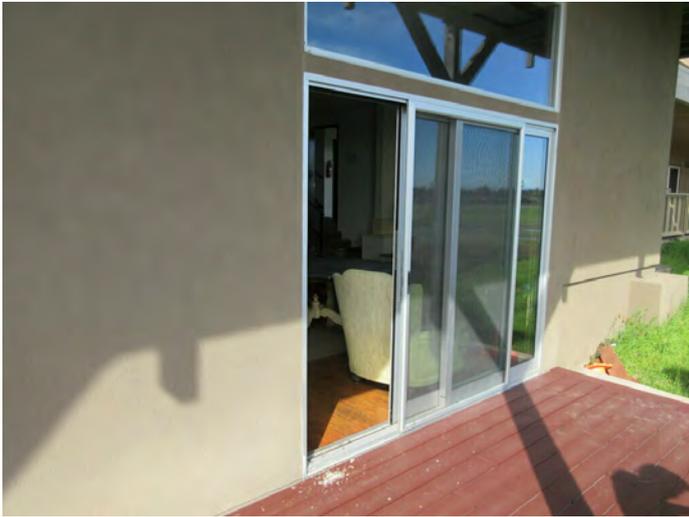
19. Sliding glass door at the deck on the lower level of the clubhouse.

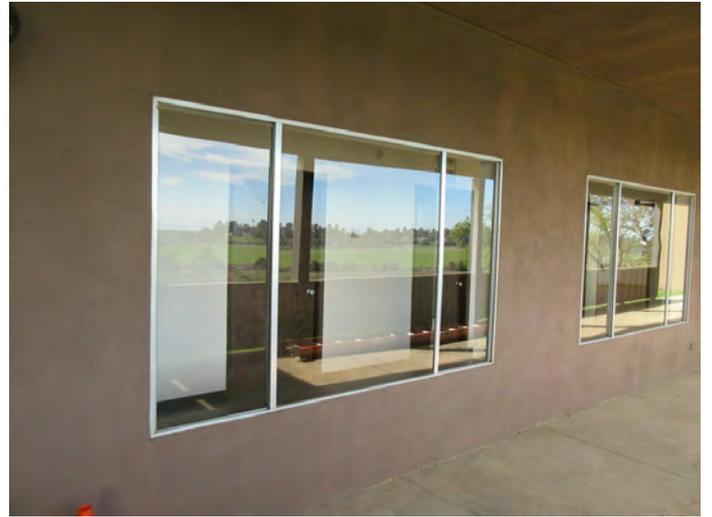
20. Clubhouse windows.

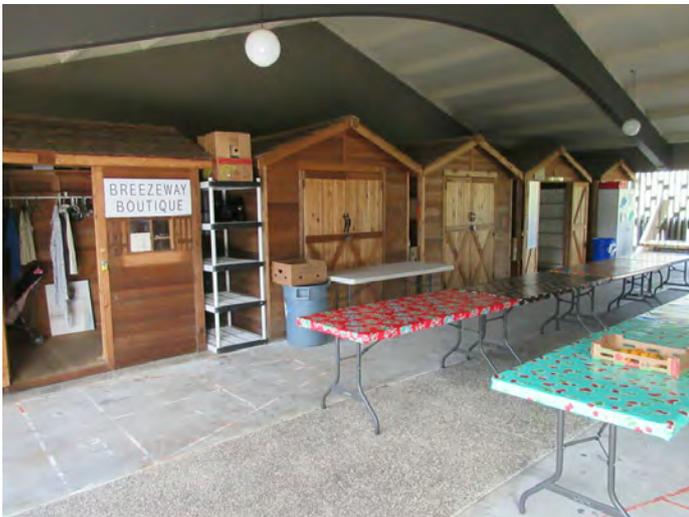
21. Fixtures and finishes in the clubhouse breezeway.

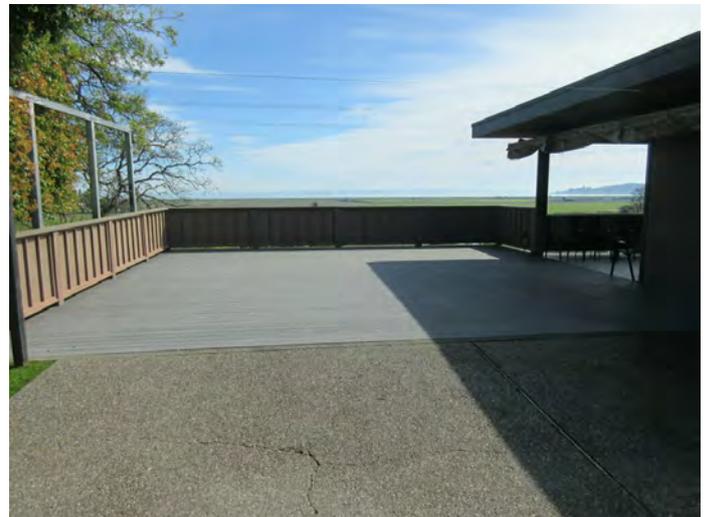
22. Fixtures and finishes at the deck on the upper level of the clubhouse.

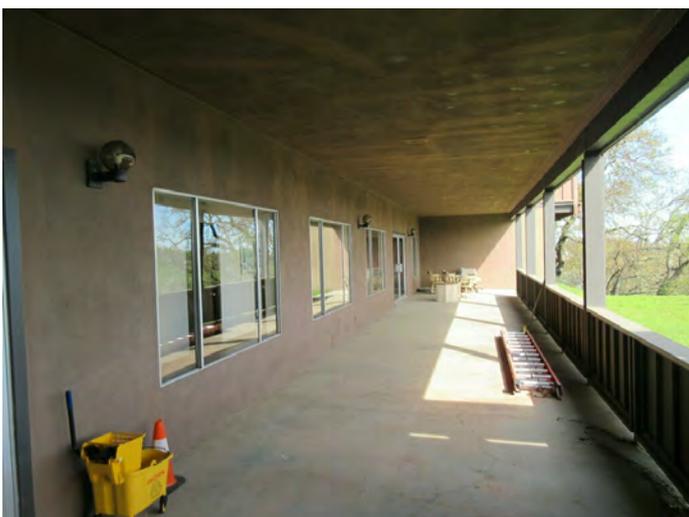
23. Fixtures and finishes at the deck on the lower level of the clubhouse.

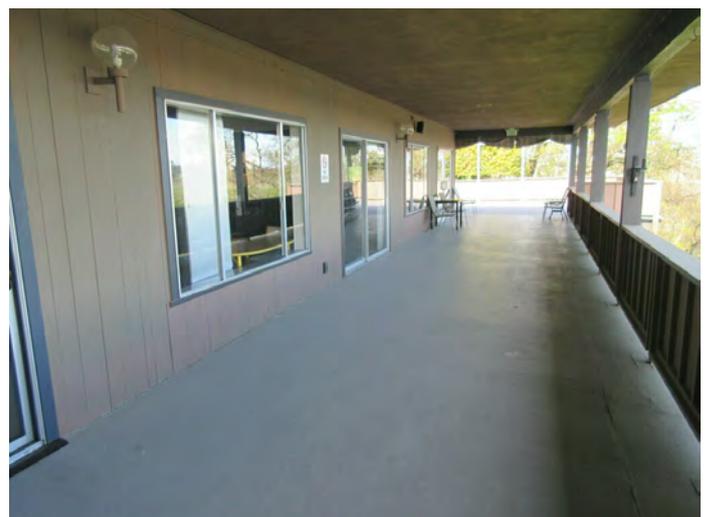
24. Upper deck on the east side of the clubhouse.

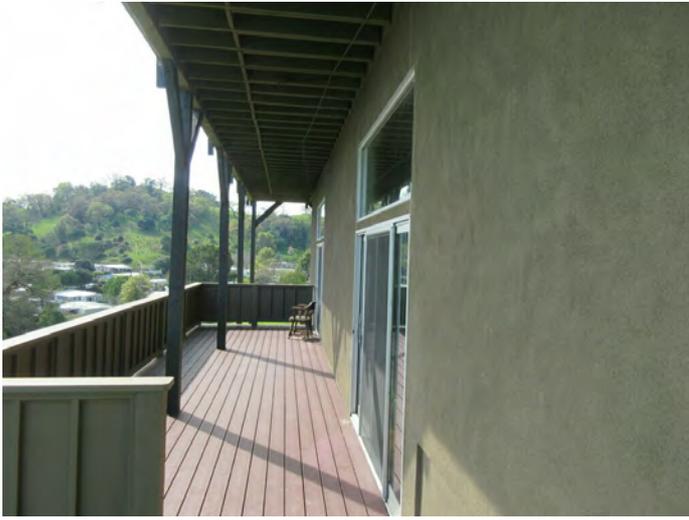
25. Fixtures and finishes at the deck on the lower level of the clubhouse.

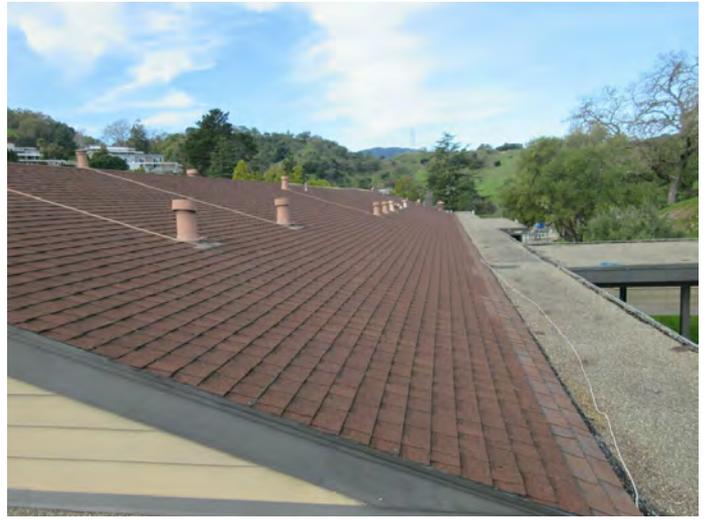
26. Overview of the clubhouse roof looking northwest.

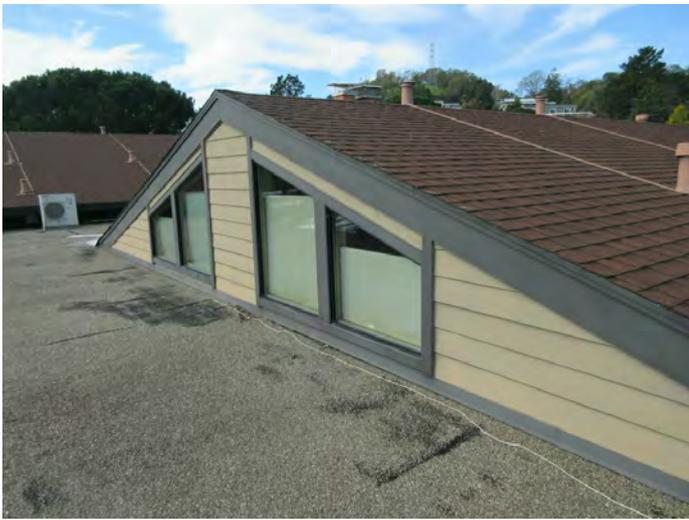
27. Clerestory windows and Hardie Plank siding on the clubhouse roof.

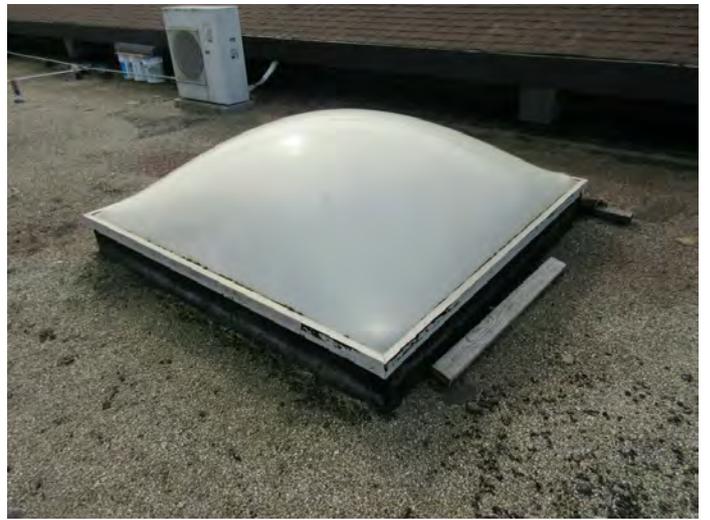
28. Skylight over the clubhouse entry lobby.

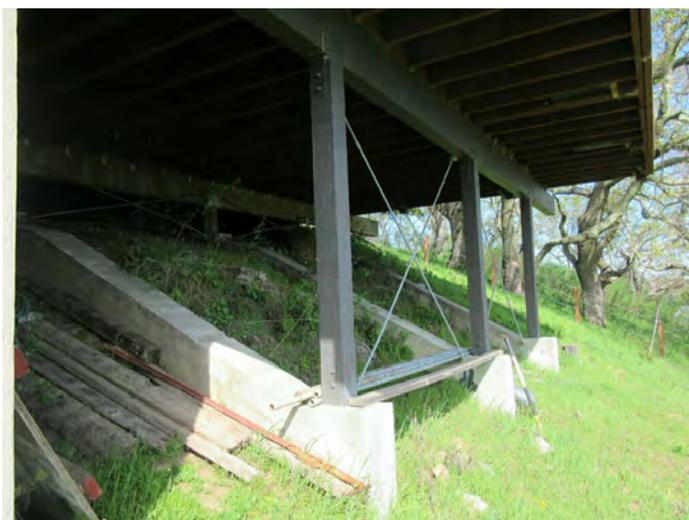
29. Deck structure on the lower level of the clubhouse.

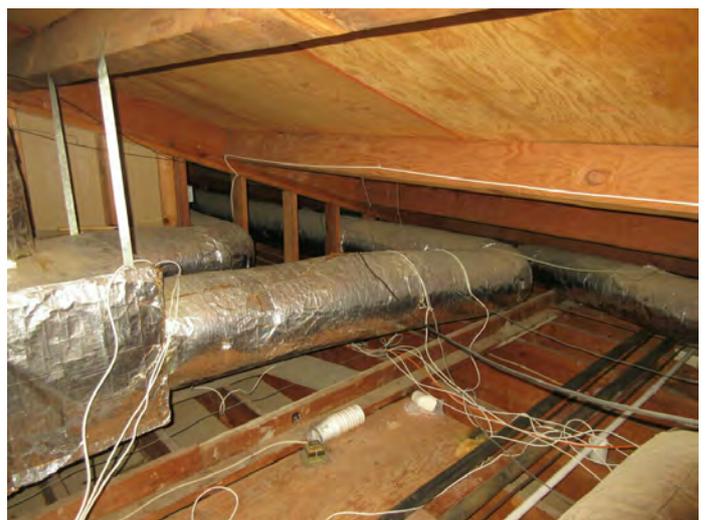
30. Clubhouse attic.

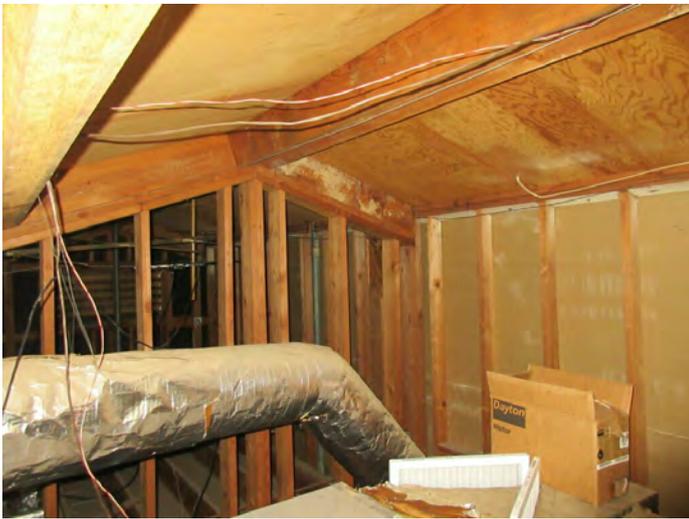
31. Clubhouse attic.

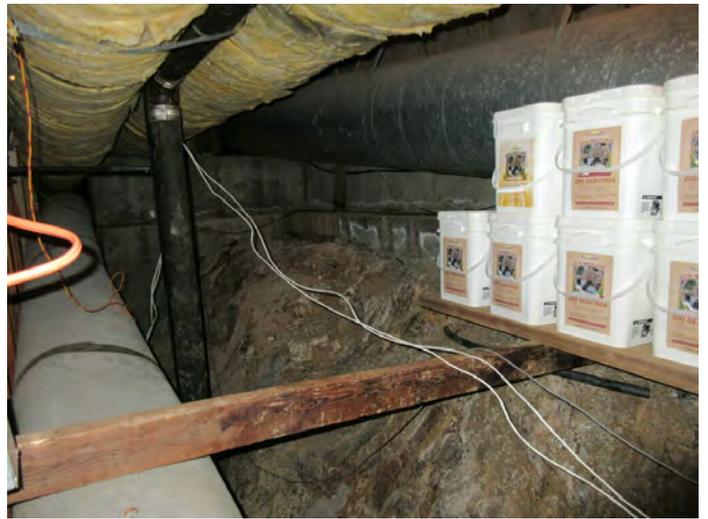
32. Clubhouse building crawlspace.

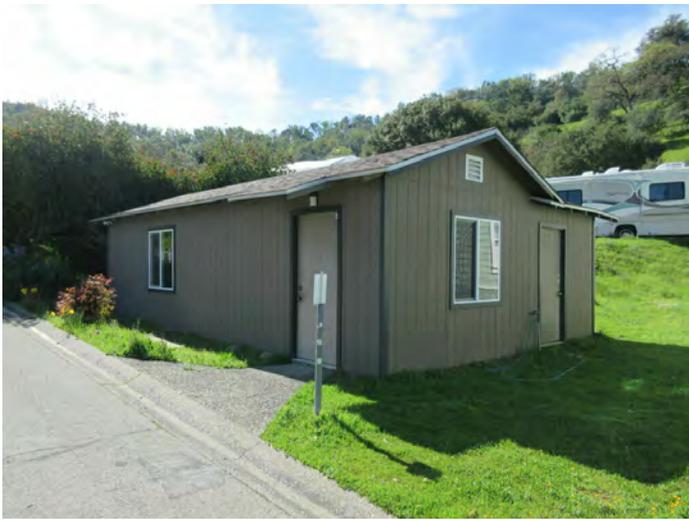
33. Laundry building looking northwest.

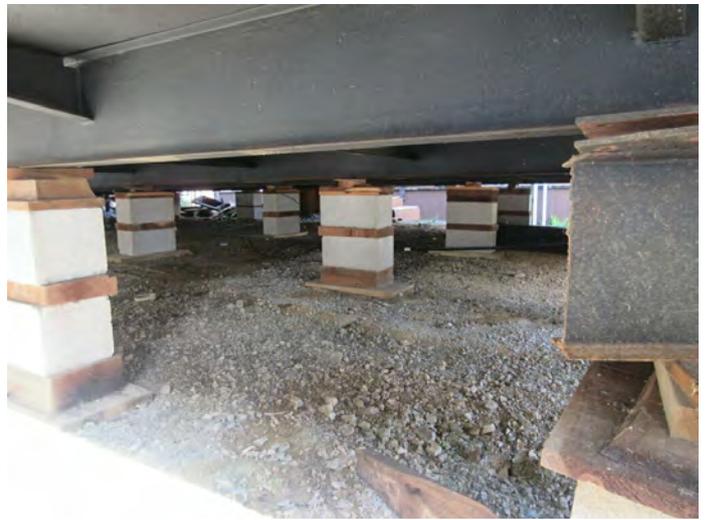
34. Common conditions at a manufactured home foundation.

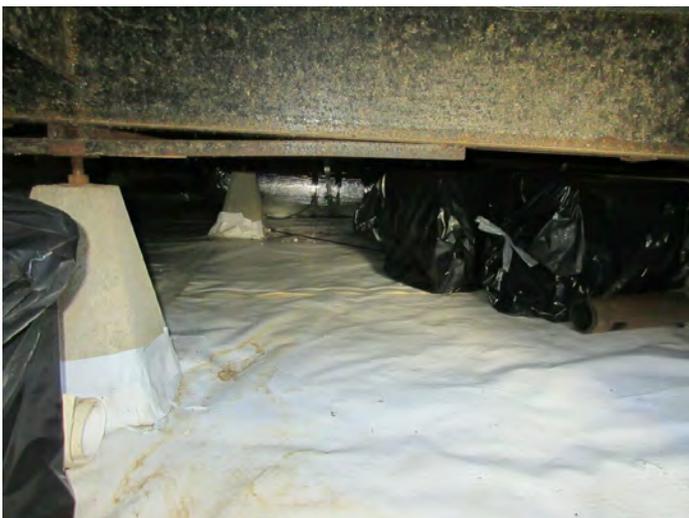
35. Manufactured home foundation.

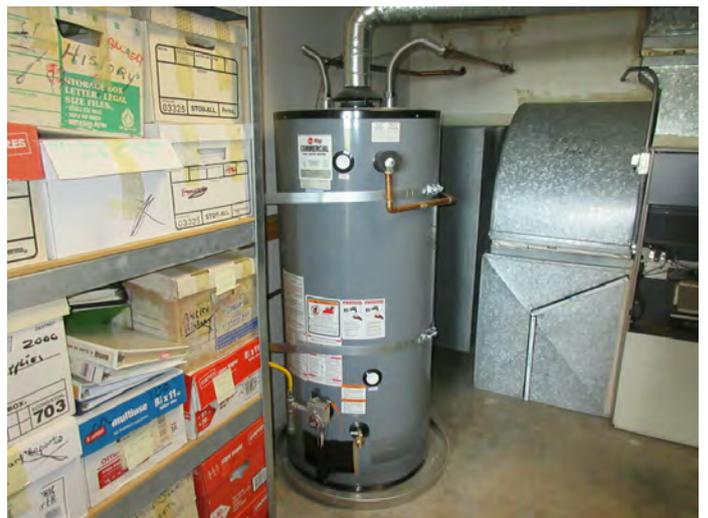
36. Water heater in the lower level of the clubhouse.

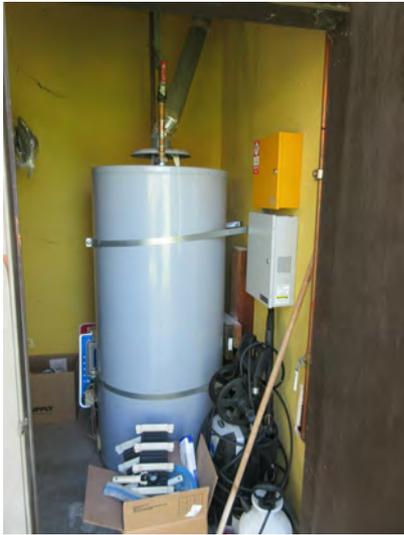
37. Water heater for the locker rooms in the clubhouse.

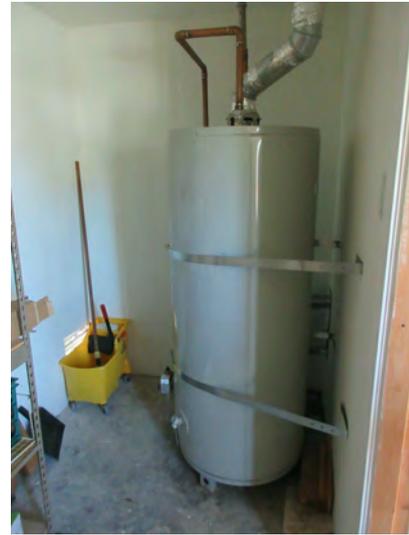
38. Water heater in the laundry building.

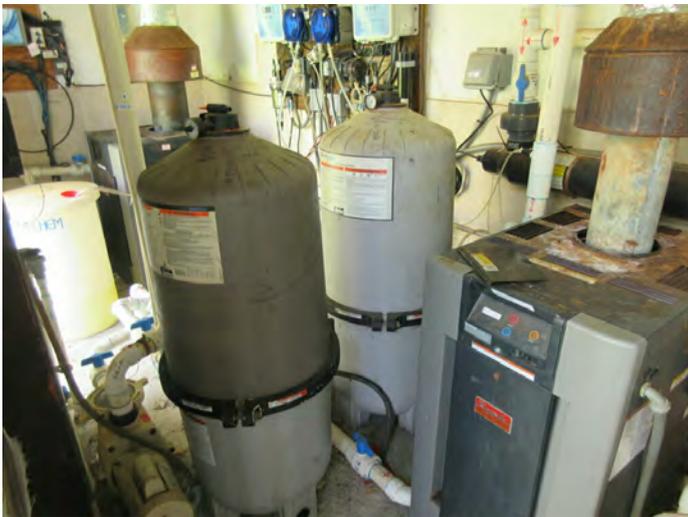
39. Pool filters.

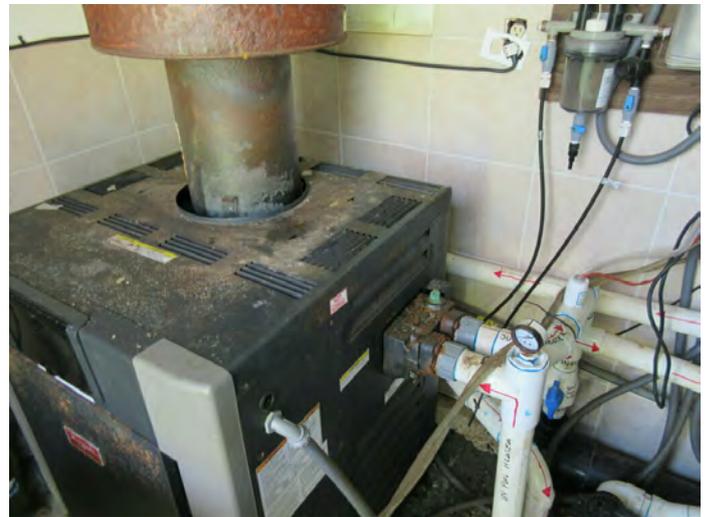
40. Swimming pool heater.

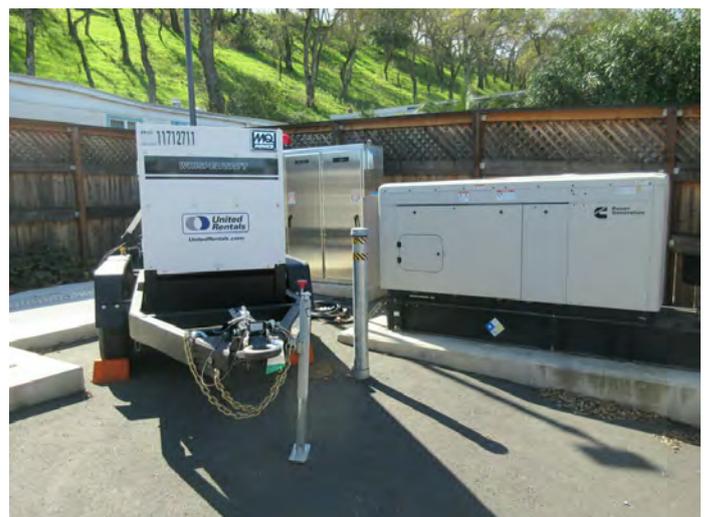
42. Temporary emergency electrical generator in the eastern lift station.

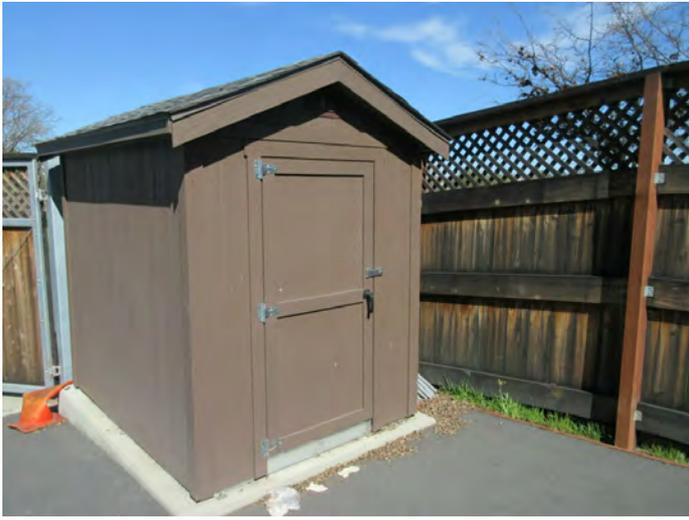
43. Storage shed in the eastern lift station.

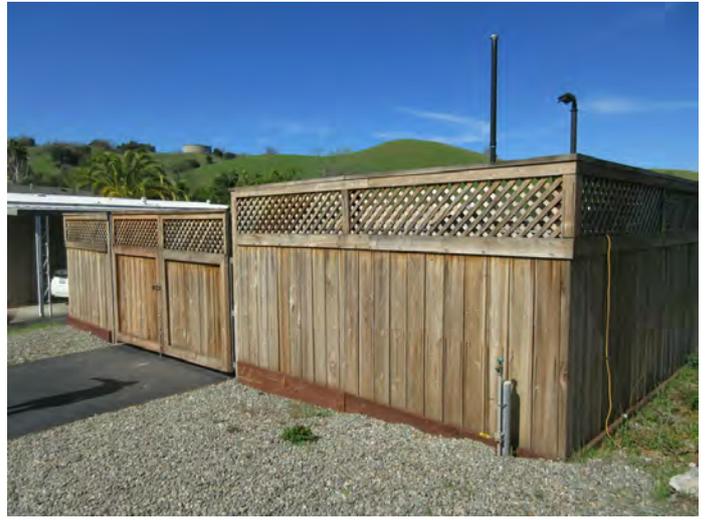
44. North lift pump enclosure.

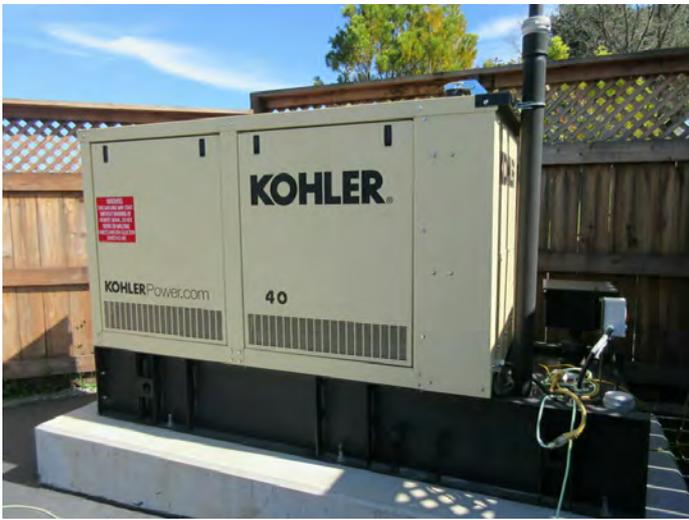
45. Emergency electrical generator for the north lift station to the west of the clubhouse.

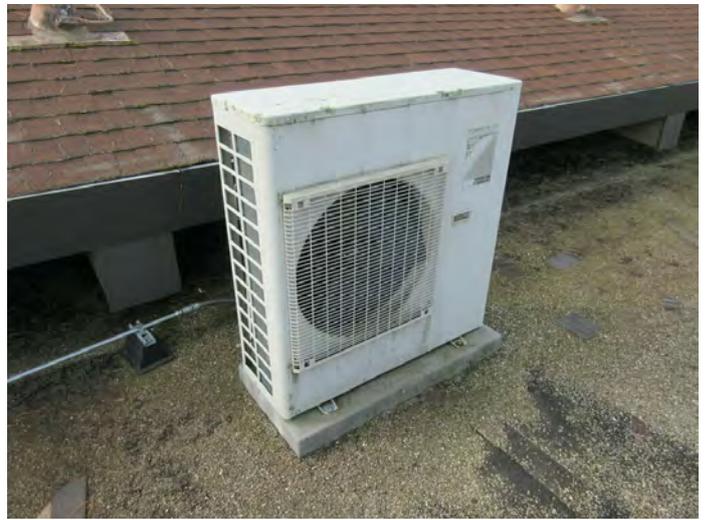
46. Mini-split condenser on the clubhouse roof.

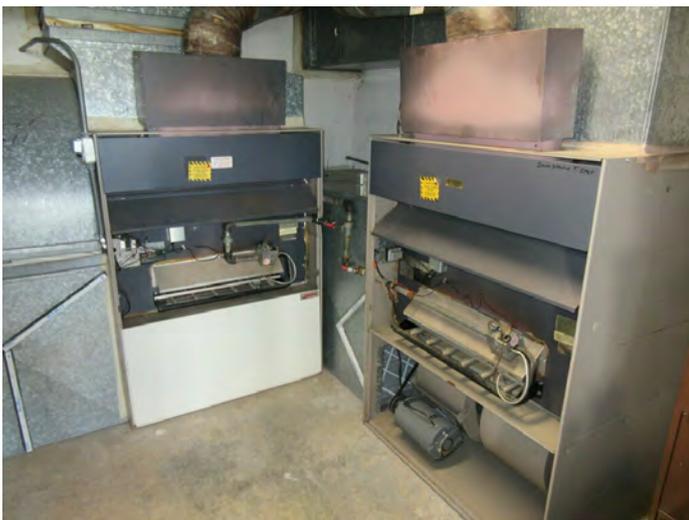
47. Natural gas-fired HVAC furnaces in the lower level of the clubhouse.

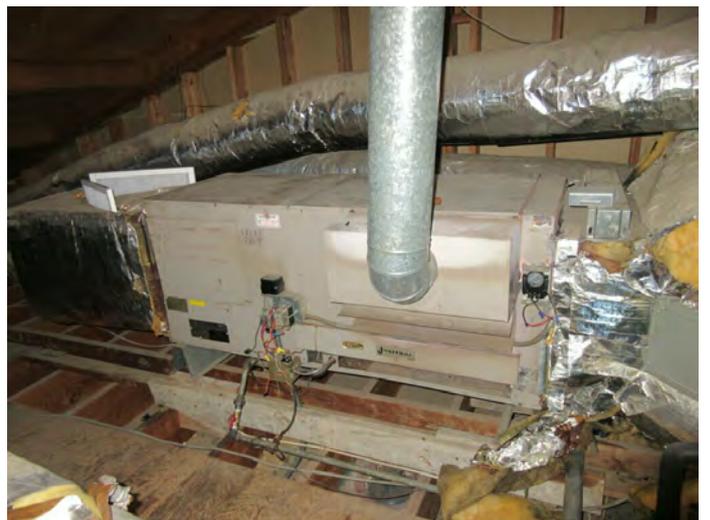
48. Furnace in the clubhouse attic.

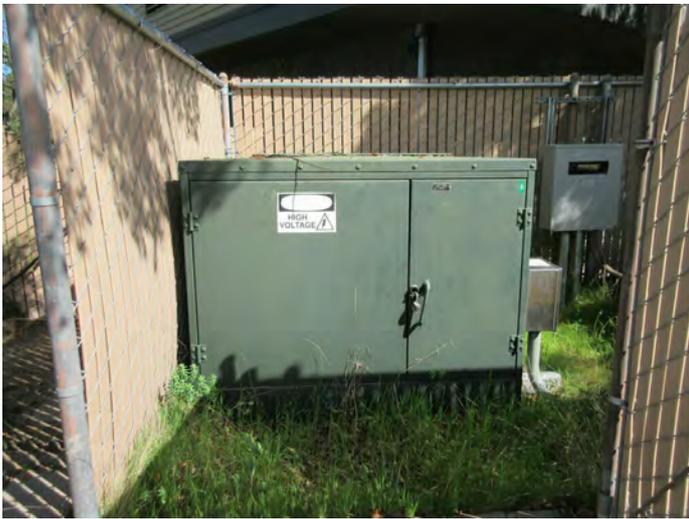
49. Pad-mounted electrical transformer.

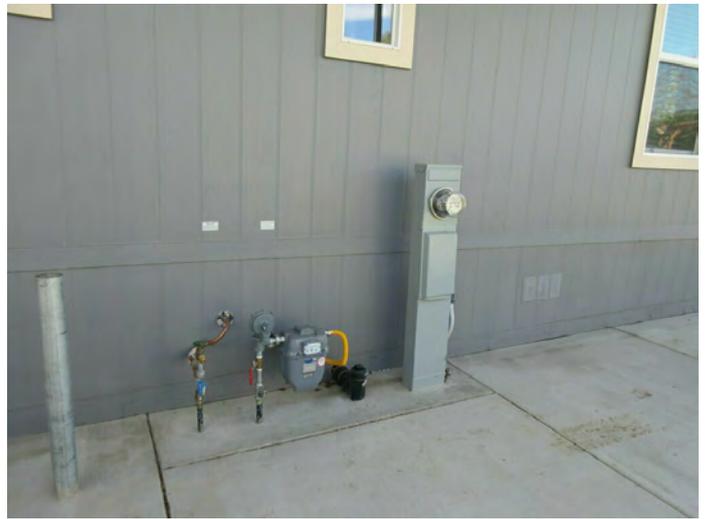
50. Utility connections at a newer manufactured home.

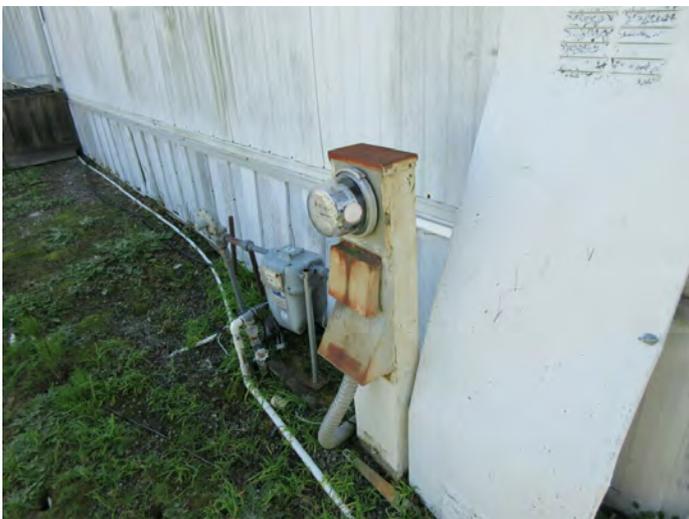
51. Utility pedestal at an older manufactured home.

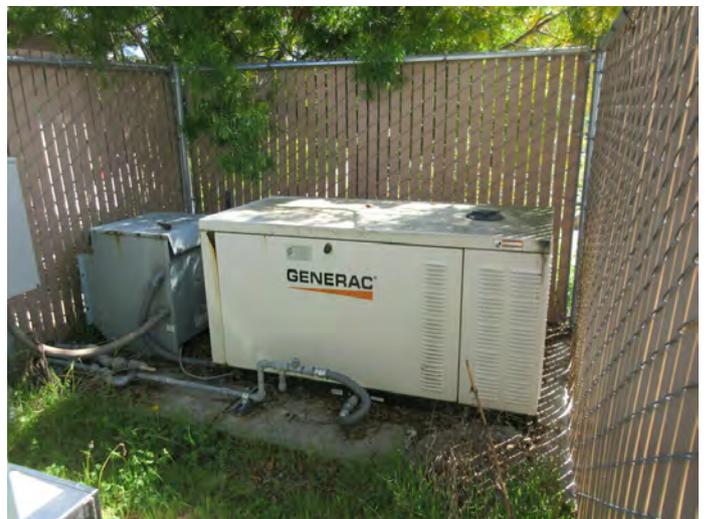
52. Propane-powered emergency electrical generator for the clubhouse.

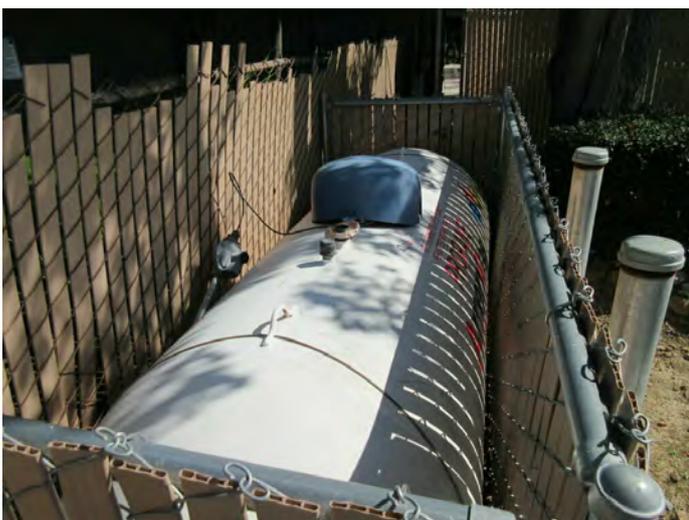
53. Propane storage tank near the electrical generator for the clubhouse.

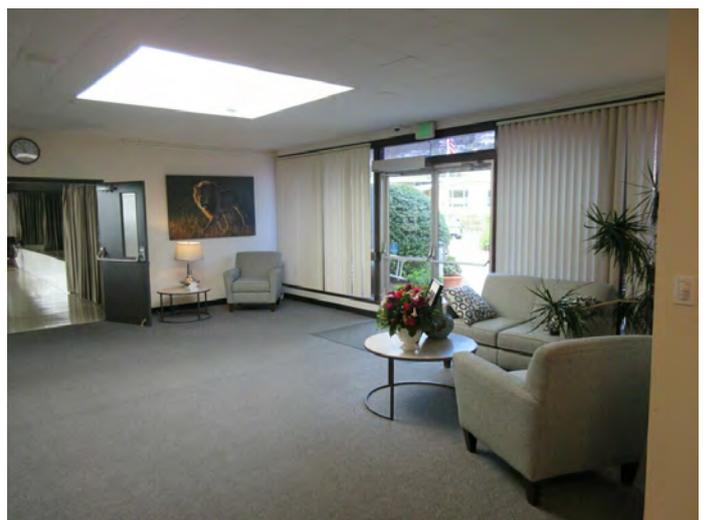
54. Fixtures and finishes in the clubhouse entry lobby.

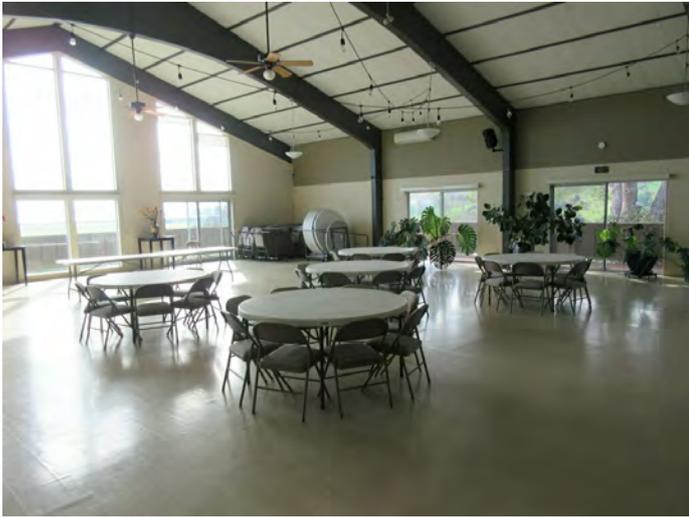
55. Fixtures and finishes in the clubhouse ballroom.

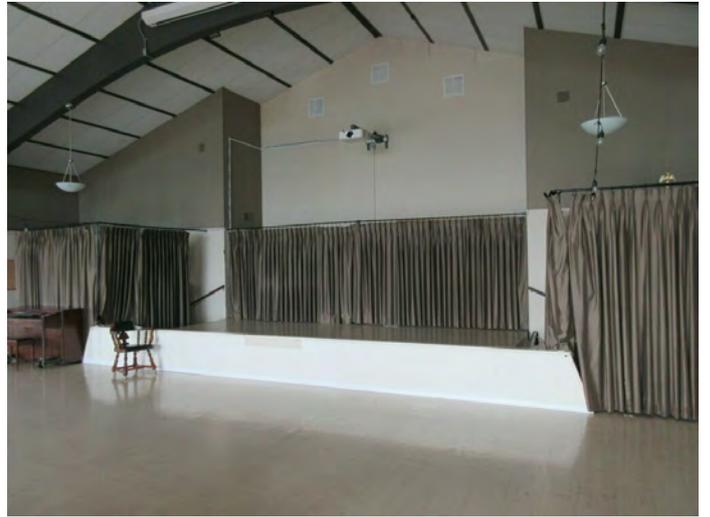
56. Stage in the ballroom.

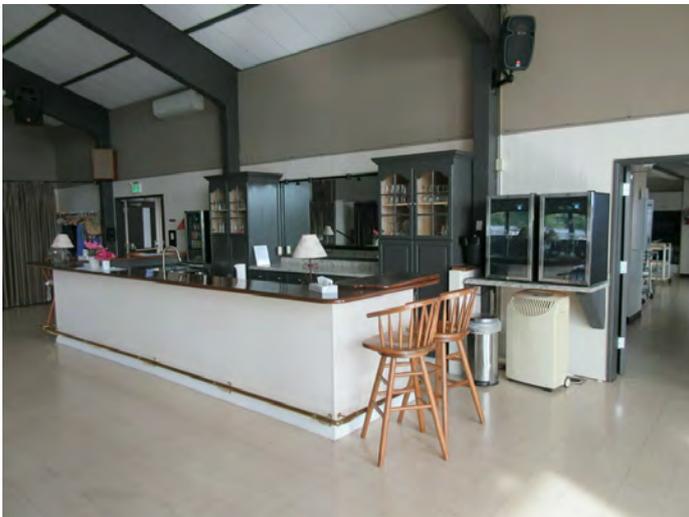
57. Bar in the ballroom.

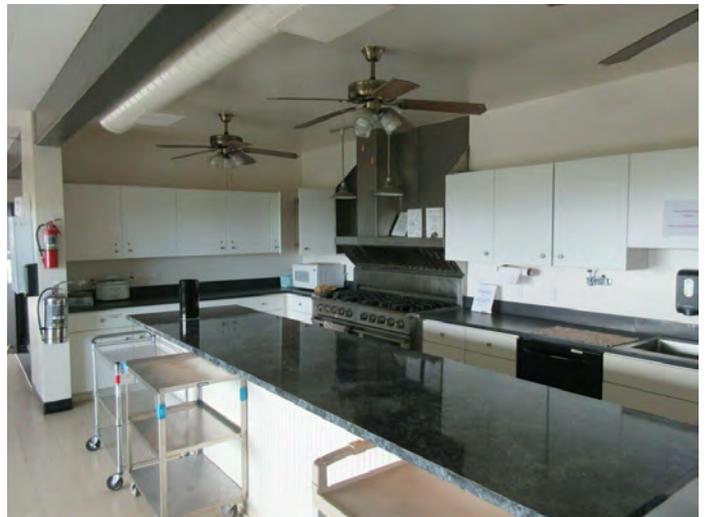
58. Fixtures and finishes in the clubhouse kitchen.

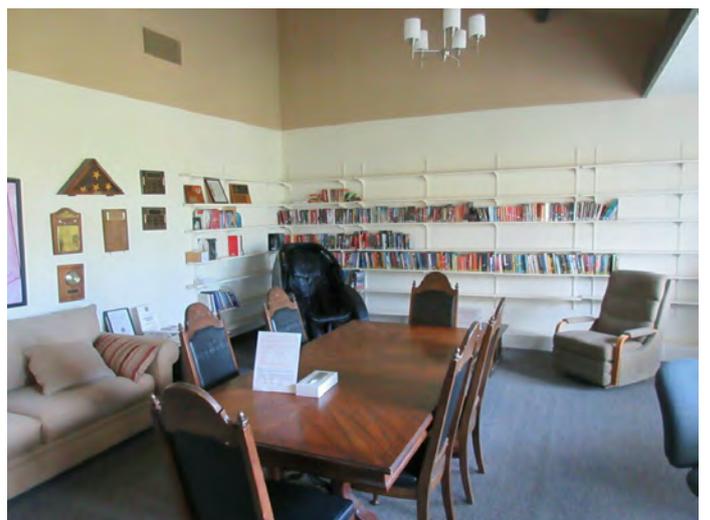
60. Fixtures and finishes in the clubhouse library.

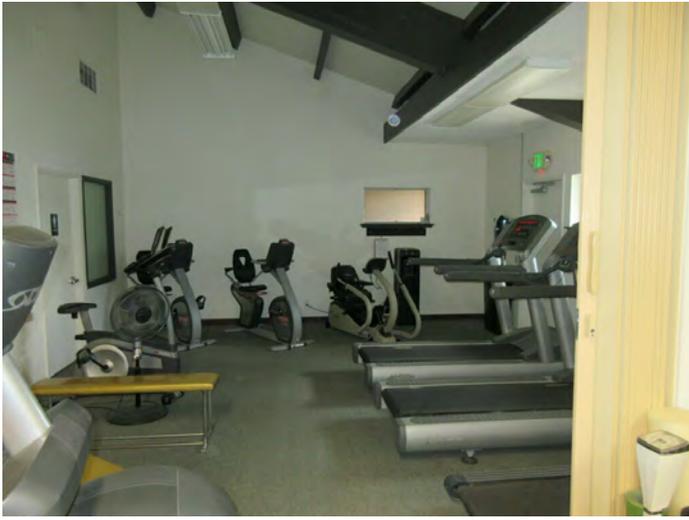
61. Fixtures and finishes in the clubhouse fitness room.

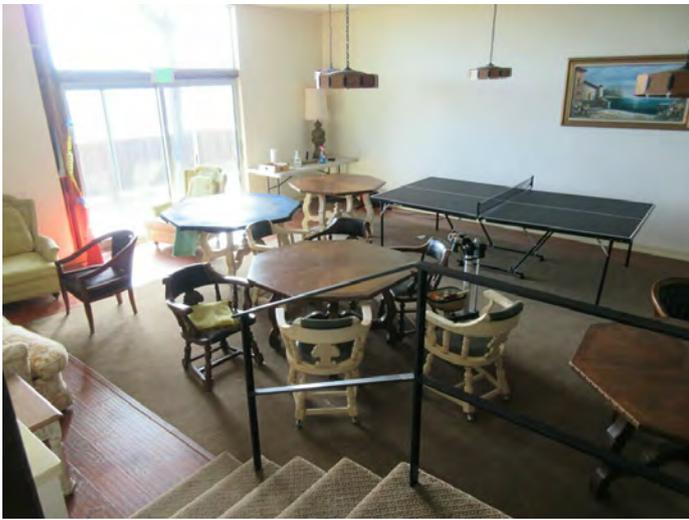
63. Fixtures and finishes at the card room in the clubhouse lower level.

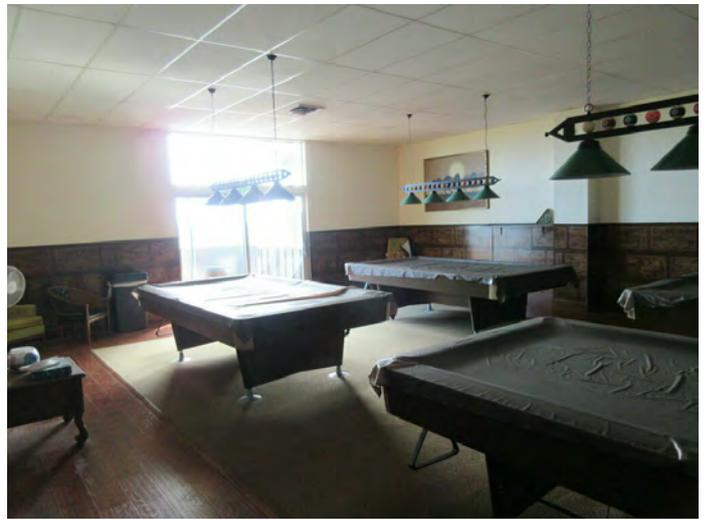
64. Fixtures and finishes at the pool room in the clubhouse lower level.

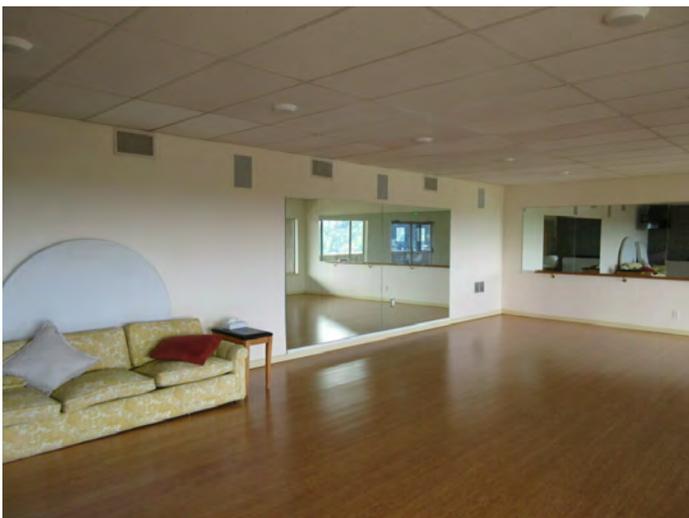
65. Dance studio on the lower level of the clubhouse.
