PROPERTY CONDITION REPORT

Marin Valley Mobile Country Club

100 Marin Valley Drive
Novato, California 94949

June 10, 2025

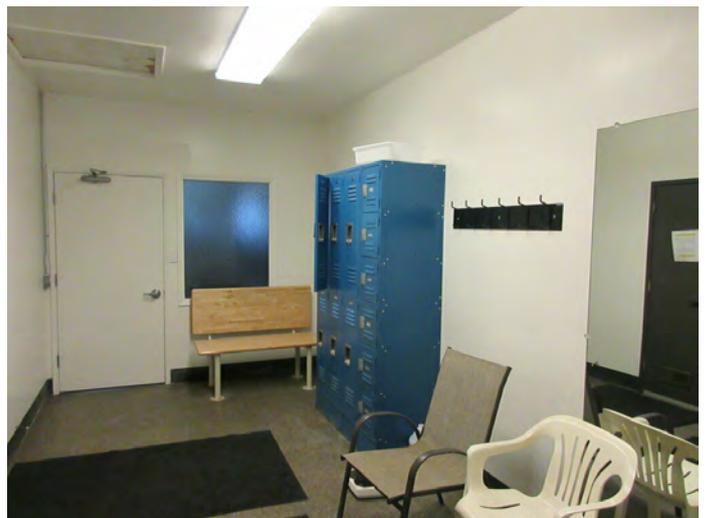
66. Fixtures and finishes in the locker room on the upper level of the clubhouse.

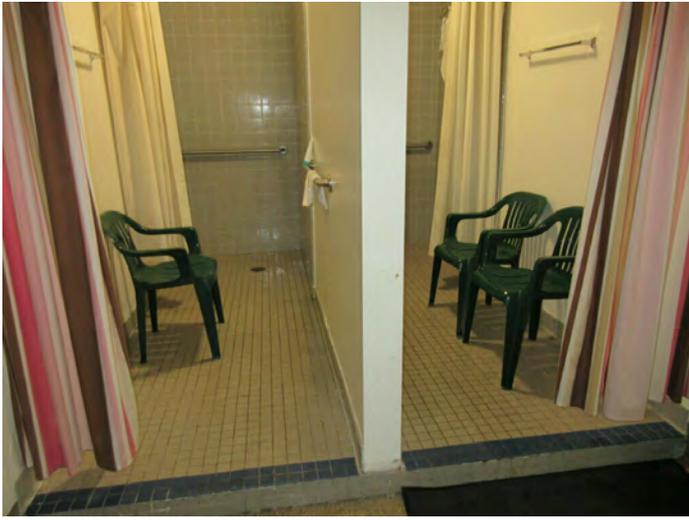
67. Showers in the locker room on the upper level of the clubhouse.

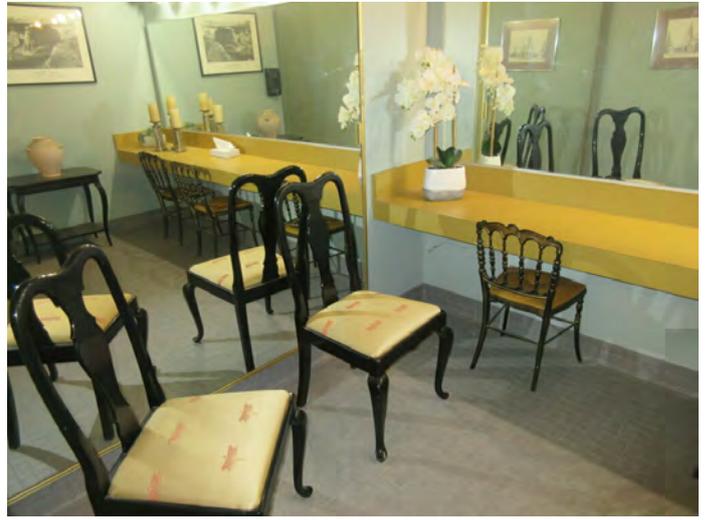
68. Fixtures and finishes in the clubhouse women's restroom.

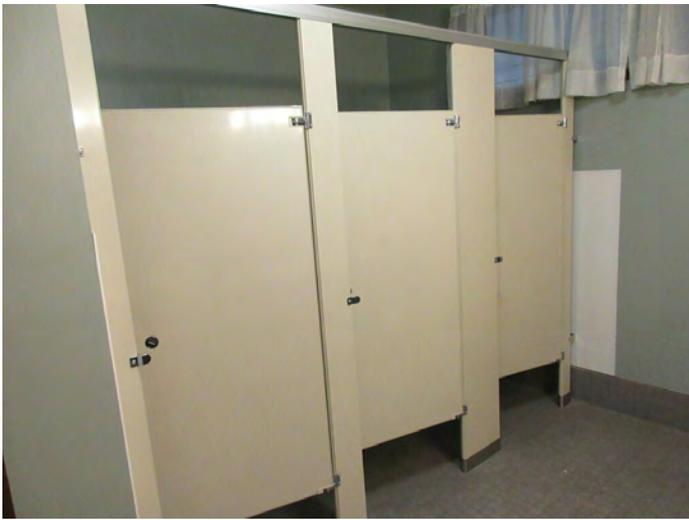
69. Fixtures and finishes in the clubhouse women's restroom.

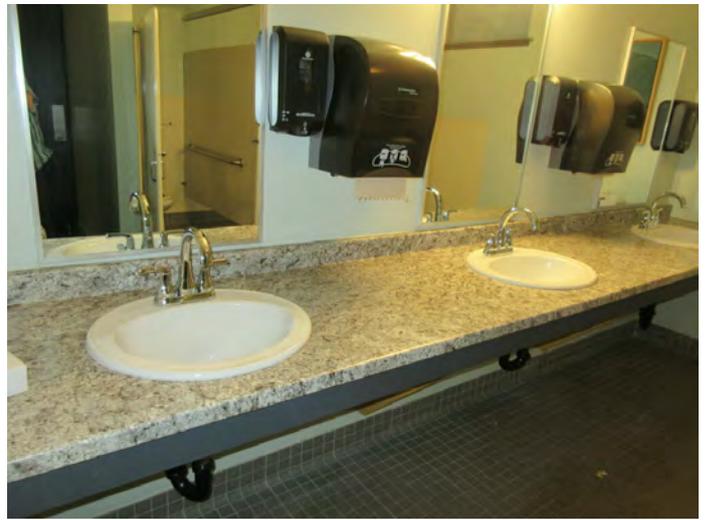
70. Fixtures and finishes in the clubhouse men's restroom.

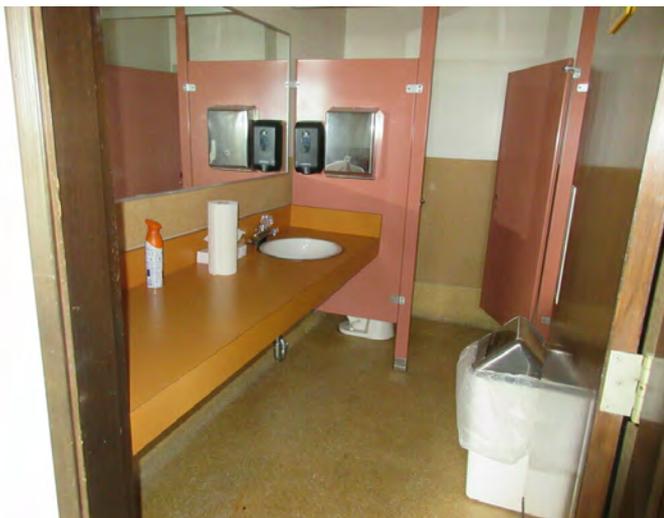
71. Fixtures and finishes in the restroom in the clubhouse lower level.

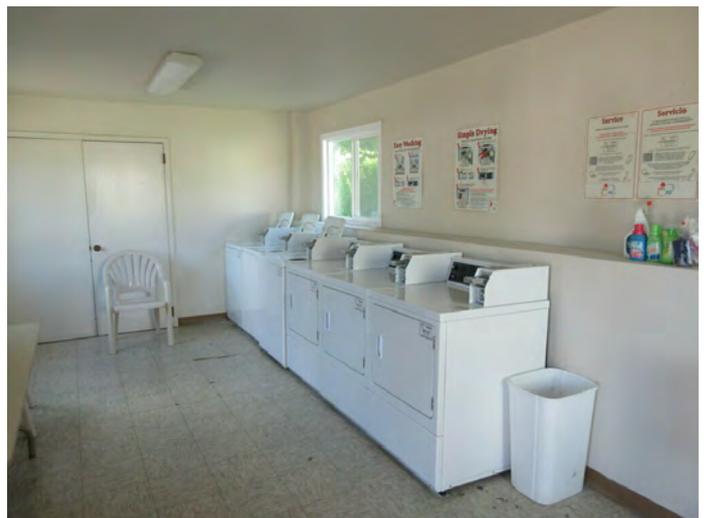
72. Fixtures and finishes in the laundry building.

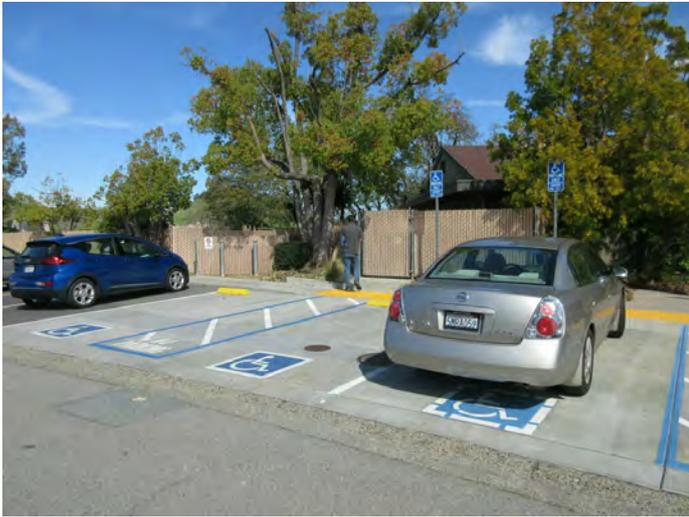
73. Accessible parking stalls near the clubhouse.

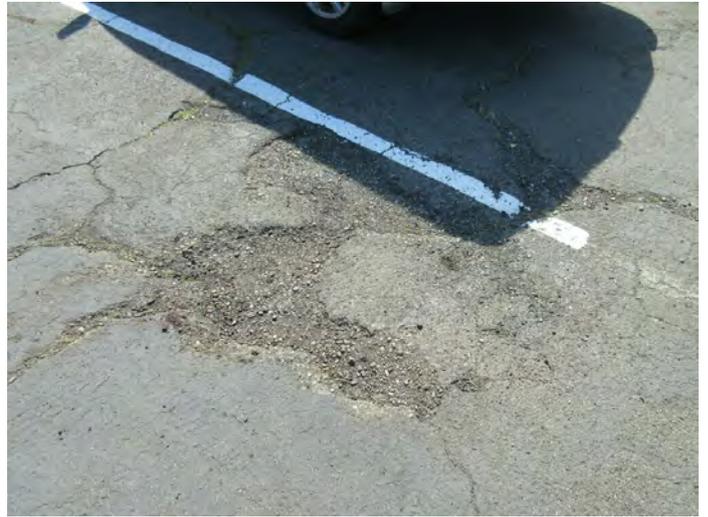
74. Pothole in the asphalt paving.

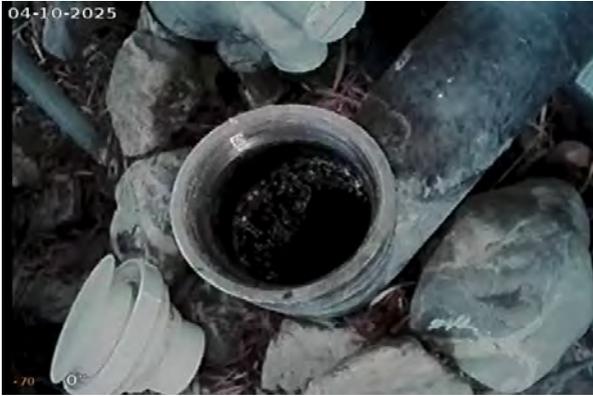
1, 00:00:00, 0.00ft
Cleanout House / SCO1 K009

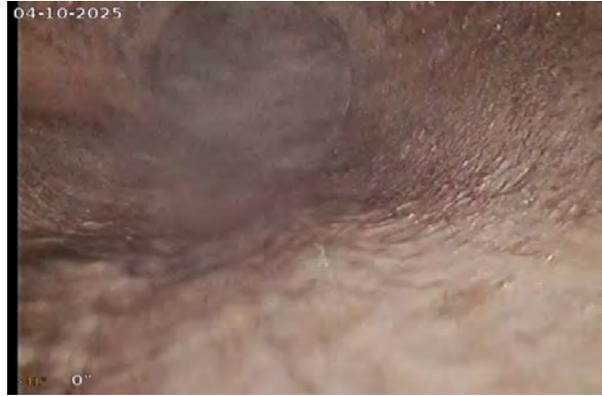
2, 00:00:30, 0.00ft
Water Level, 5% of the vertical dimension

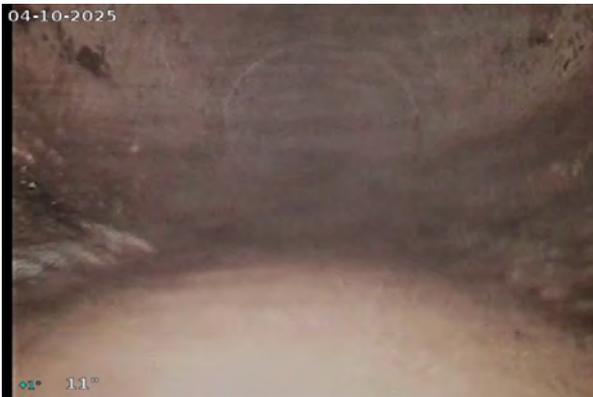
3, 00:01:06, 11.00ft
Deposits Attached Other, 5% of cross sectional area from 12 o'clock to 12 o'clock, Start / DEPOSITS ATTACHED

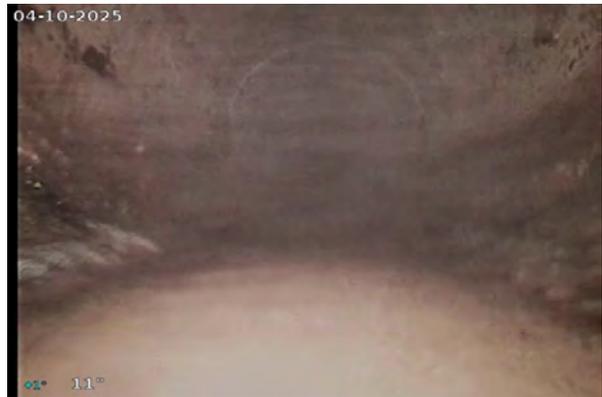
4, 00:01:06, 12.00ft
Deposits Attached Grease, 5% of cross sectional area from 5 o'clock to 7 o'clock, Start

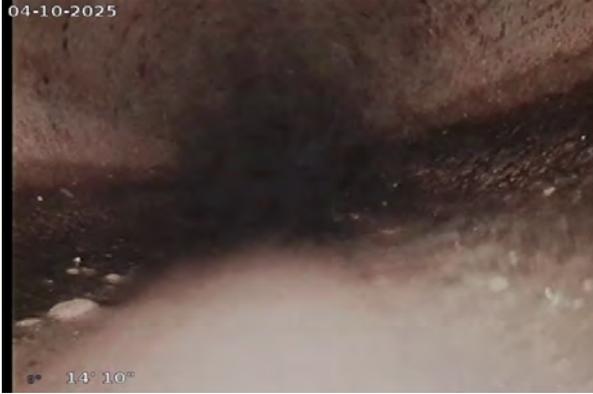
5, 00:01:43, 14.00ft
Deposits Settled Fine, 5% of cross sectional area from 5 o'clock to 7 o'clock, Start

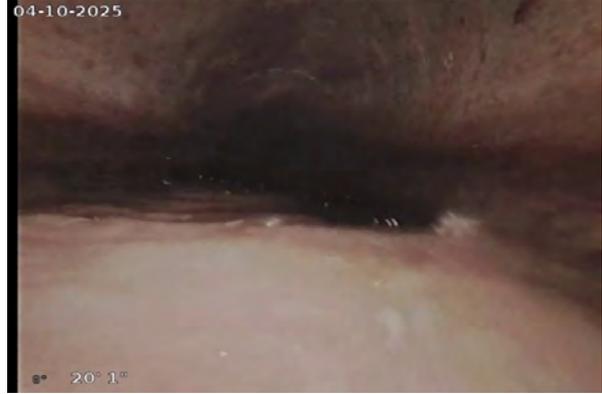
6, 00:01:54, 20.00ft
Water Level, 10% of the vertical dimension

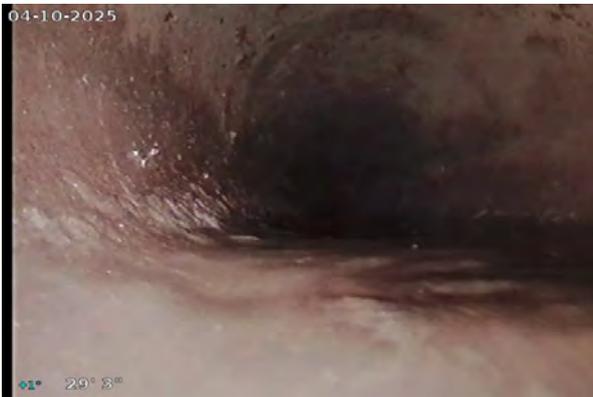
7, 00:02:11, 28.00ft
Deposits Attached Encrustation, 5% of cross sectional area from 10 o'clock to 2 o'clock, Start

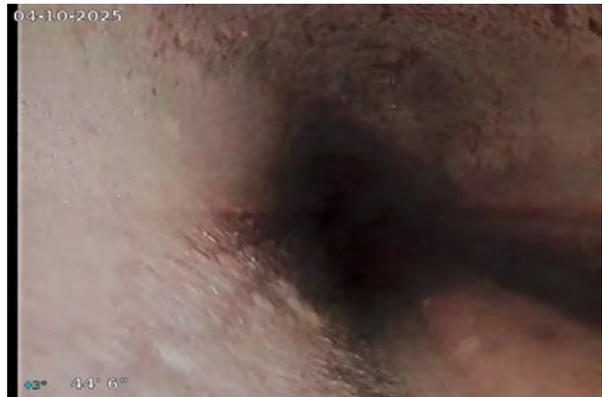
8, 00:02:44, 44.00ft
Water Level, 5% of the vertical dimension

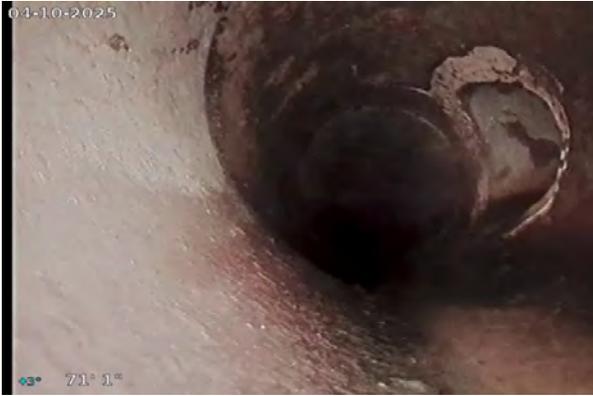
9, 00:03:23, 72.00ft
Tap Factory Made at 3 o'clock, dia/height: 4inch

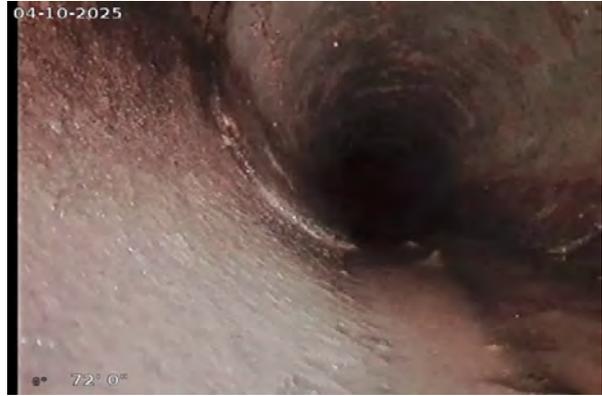
10, 00:03:38, 72.00ft
Deposits Attached Other, 5% of cross sectional area from 12 o'clock to 12 o'clock, Finish / DEPOSITS ATTACHED

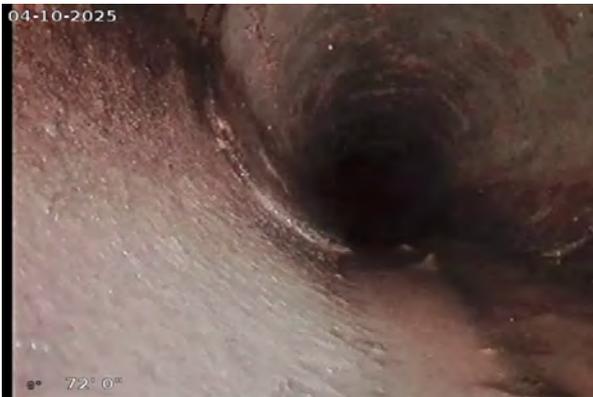
11, 00:03:38, 72.00ft
Deposits Attached Grease, 5% of cross sectional area from 5 o'clock to 7 o'clock, Finish

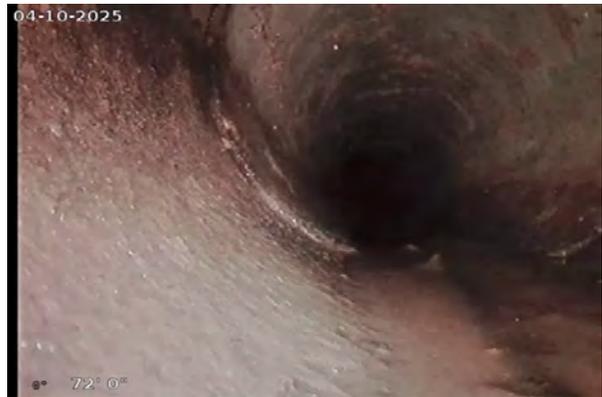
12, 00:03:38, 72.00ft
Deposits Settled Fine, 5% of cross sectional area from 5 o'clock to 7 o'clock, Finish

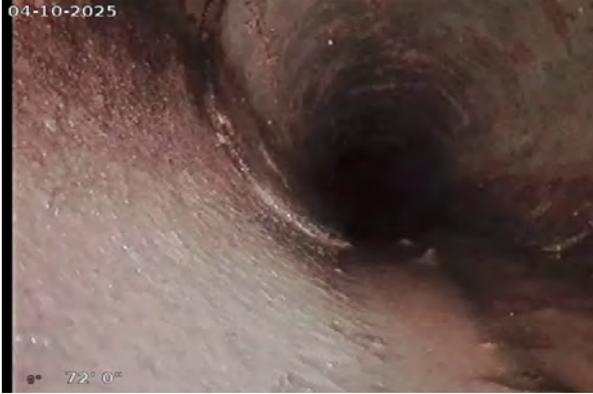
13, 00:03:38, 72.00ft
Deposits Attached Encrustation, 5% of cross sectional area
from 10 o'clock to 2 o'clock, Finish

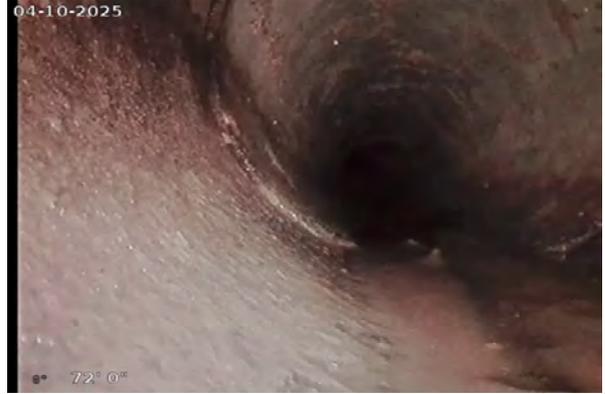
14, 00:03:38, 72.00ft
Miscellaneous Survey Abandoned / COULD NOT PUSH
CAMERA FURTHER

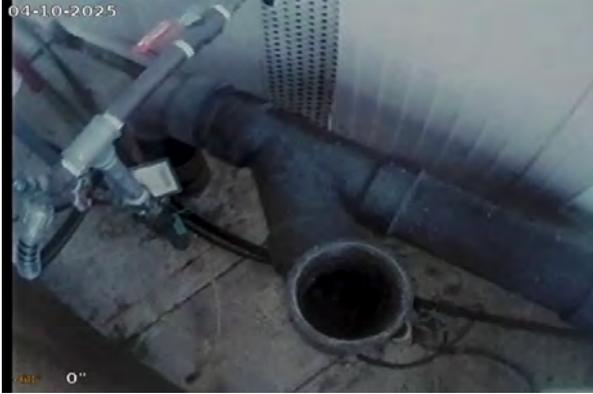
1, 00:00:00, 0.00ft
Cleanout House / SCO2 K033

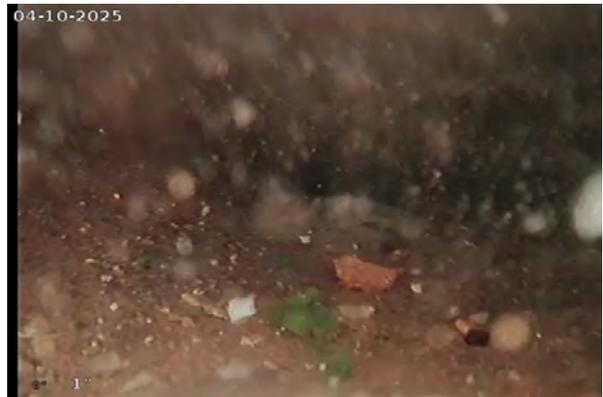
4, 00:00:59, 1.00ft
Deposits Settled Fine, 5% of cross sectional area from 5 o'clock to 7 o'clock

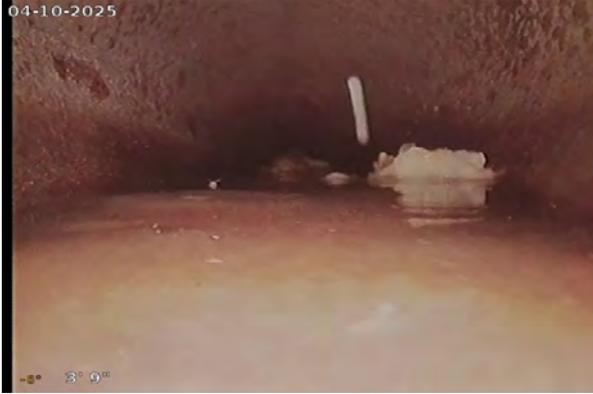
5, 00:01:08, 3.00ft
Water Level, 10% of the vertical dimension

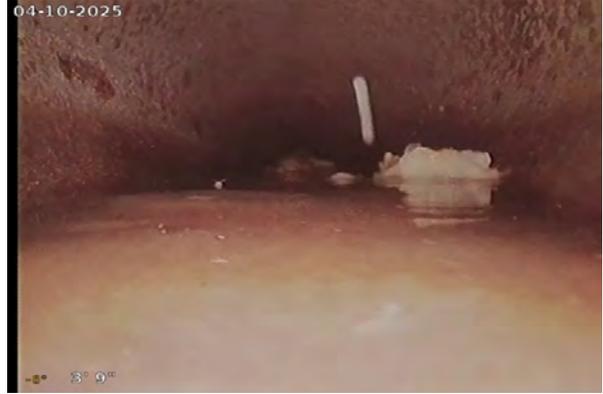
6, 00:01:08, 3.00ft
Deposits Attached Grease, 5% of cross sectional area from 9 o'clock to 3 o'clock, Start

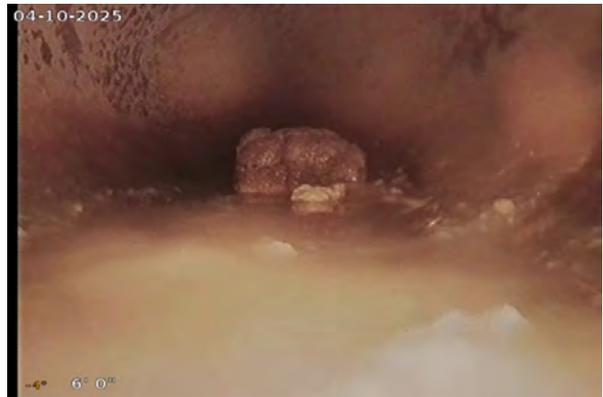
8, 00:01:14, 6.00ft
Deposits Settled Other, 10% of cross sectional area from 5 o'clock to 7 o'clock / DEPOSITS SETTLED

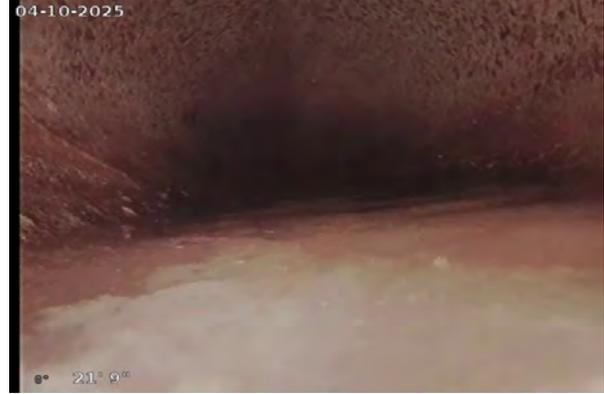
10, 00:01:52, 21.00ft
Miscellaneous Camera Underwater, Finish

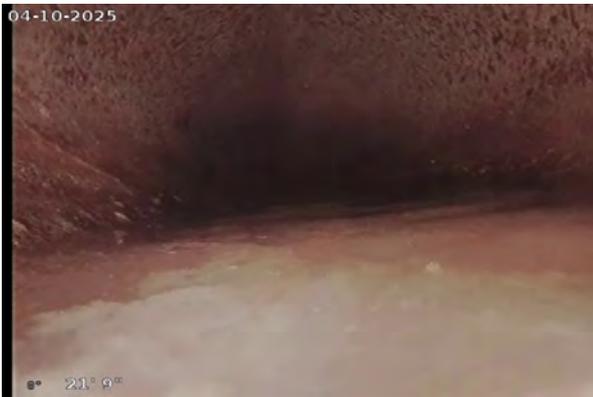
11, 00:01:52, 21.00ft
Water Level, 10% of the vertical dimension

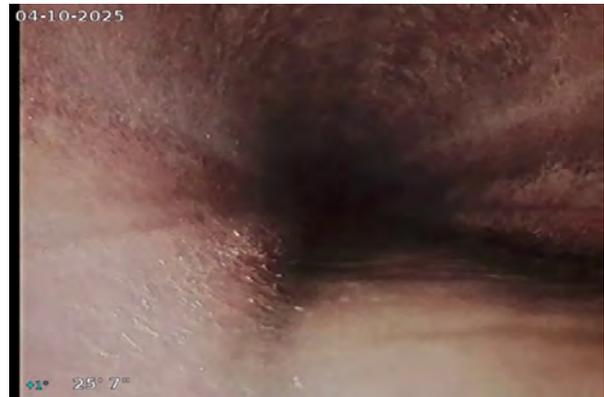
12, 00:02:01, 22.00ft
Deposits Settled Fine, 5% of cross sectional area from 4 o'clock to 8 o'clock, Start

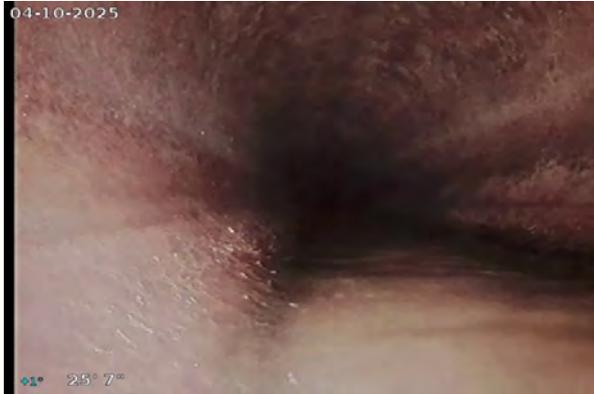
13, 00:02:01, 22.00ft
Deposits Attached Other, 5% of cross sectional area from 8 o'clock to 4 o'clock, Start / DEPOSITS ATTACHED

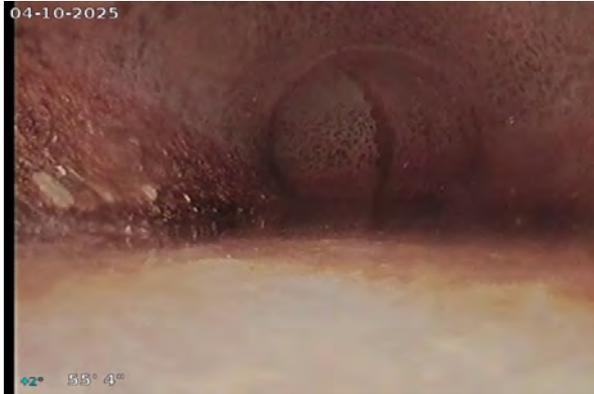
17, 00:03:05, 57.00ft
Line Left, change to: 90%

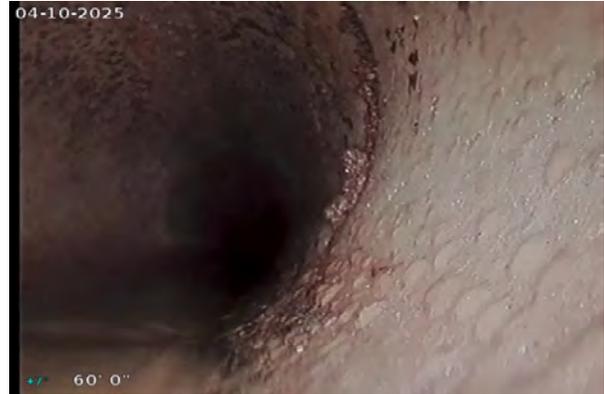
18, 00:03:52, 60.00ft
Water Level, 5% of the vertical dimension

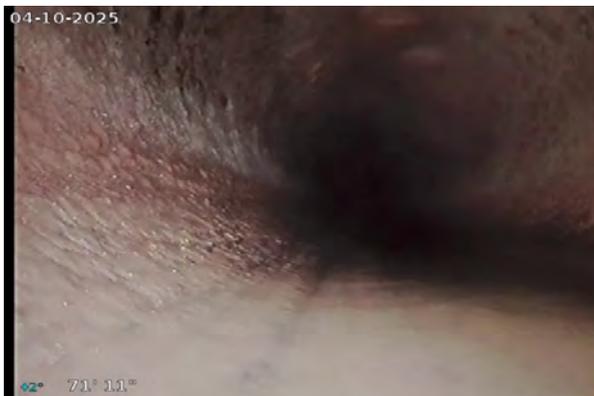
19, 00:04:33, 72.00ft
Deposits Attached Grease, 5% of cross sectional area from 9 o'clock to 3 o'clock, Finish

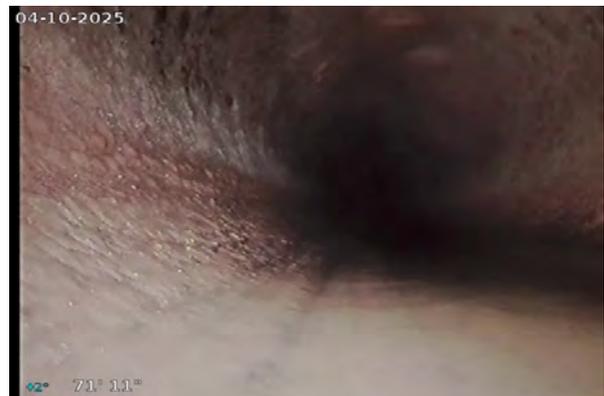
20, 00:04:33, 72.00ft
Deposits Settled Fine, 5% of cross sectional area from 4 o'clock to 8 o'clock, Finish

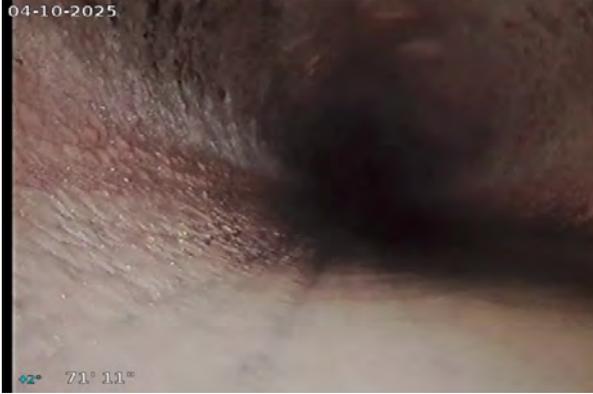
21, 00:04:33, 72.00ft
Deposits Attached Other, 5% of cross sectional area from 8 o'clock to 4 o'clock, Finish / DEPOSITS ATTACHED

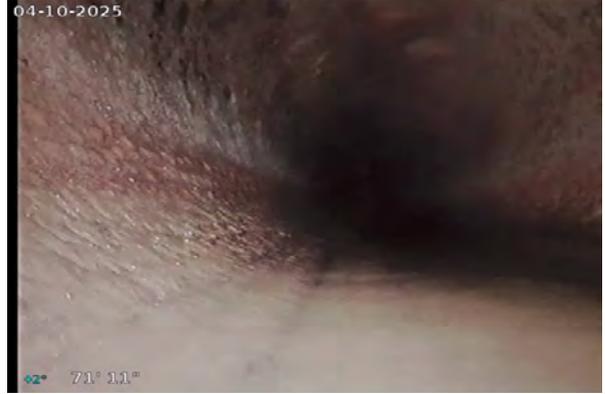
22, 00:04:33, 72.00ft
Miscellaneous Survey Abandoned / CANNOT PUSH CAMERA FURTHER

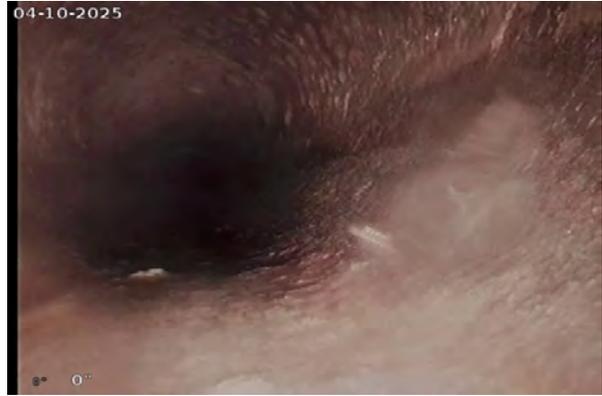
2, 00:00:21, 0.00ft
Water Level, 5% of the vertical dimension

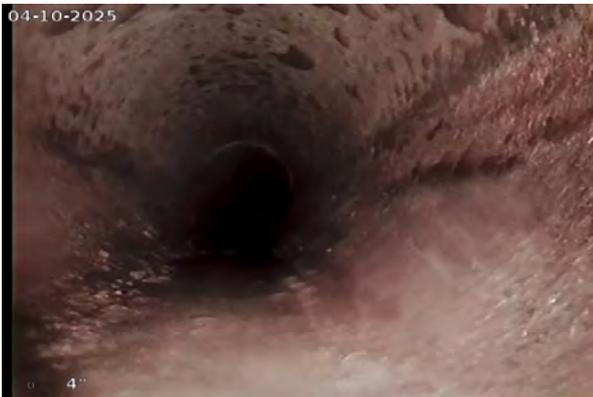
3, 00:00:22, 1.00ft
Deposits Settled Fine, 5% of cross sectional area from 5 o'clock to 7 o'clock, Start

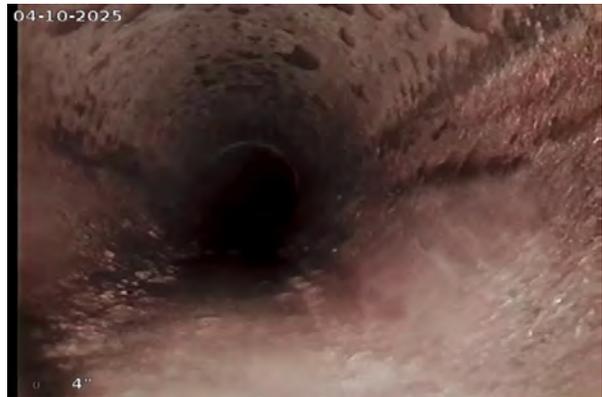
4, 00:00:22, 1.00ft
Deposits Attached Grease, 5% of cross sectional area from 12 o'clock to 12 o'clock, Start

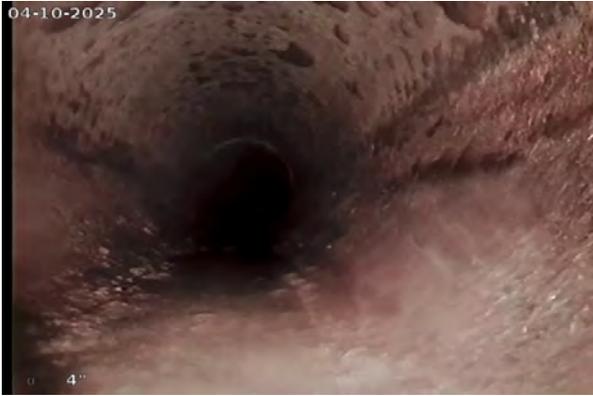
5, 00:00:22, 1.00ft
Deposits Attached Other, 5% of cross sectional area from 12 o'clock to 12 o'clock, Start / DEPOSITS ATTACHED

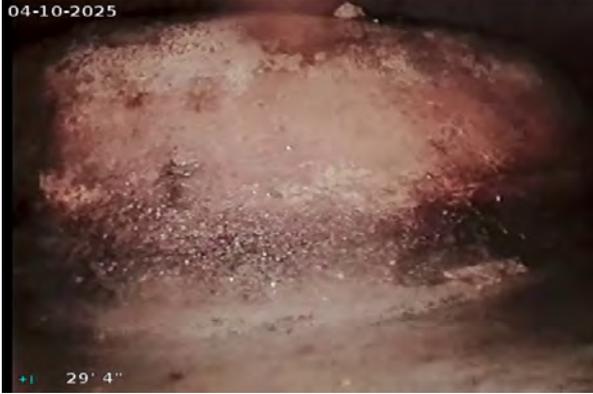
9, 00:01:41, 30.00ft
Deposits Settled Fine, 5% of cross sectional area from 5 o'clock to 7 o'clock, Finish

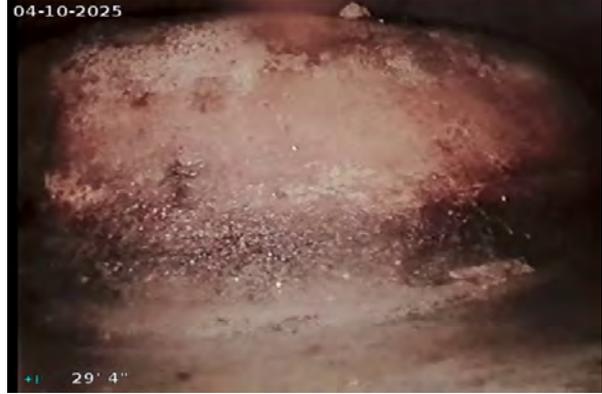
10, 00:01:41, 30.00ft
Deposits Attached Grease, 5% of cross sectional area from 12 o'clock to 12 o'clock, Finish

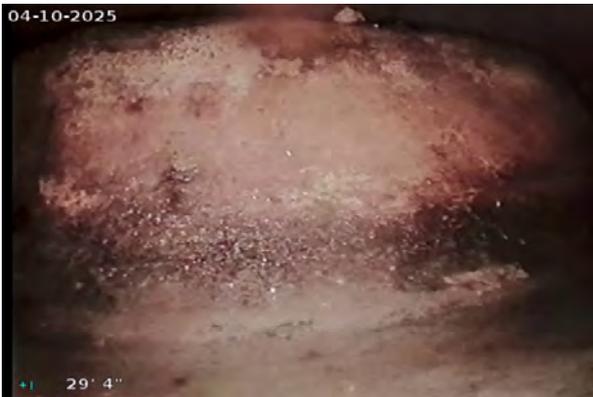
11, 00:01:41, 30.00ft
Deposits Attached Other, 5% of cross sectional area from 12 o'clock to 12 o'clock, Finish / DEPOSITS ATTACHED

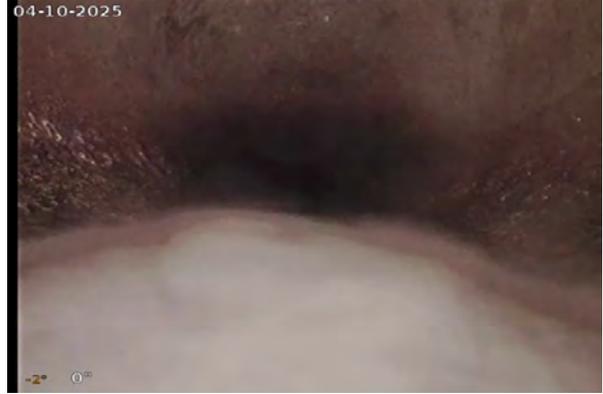
2, 00:00:29, 0.00ft
Water Level, 5% of the vertical dimension

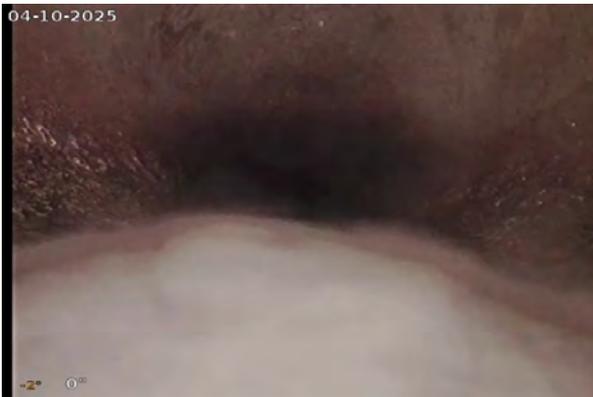
3, 00:00:29, 1.00ft
Deposits Attached Other, 5% of cross sectional area from 8 o'clock to 4 o'clock, Start / DEPOSITS ATTACHED

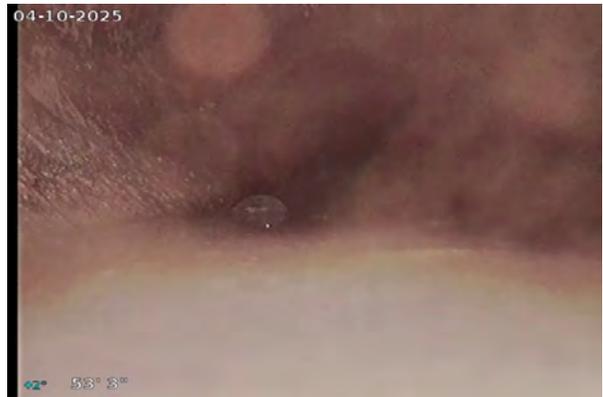
4, 00:01:40, 53.00ft
Water Level, 10% of the vertical dimension

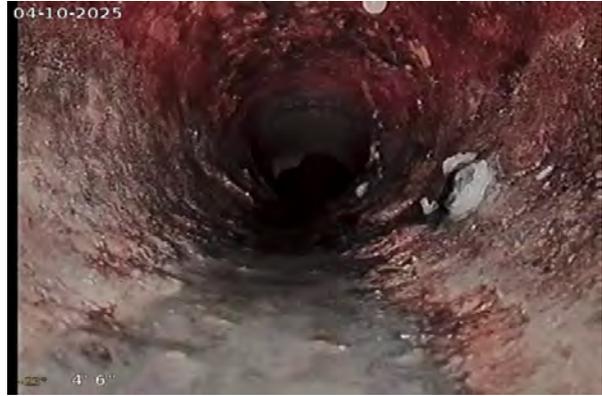
2, 00:00:27, 0.00ft
Water Level, 5% of the vertical dimension

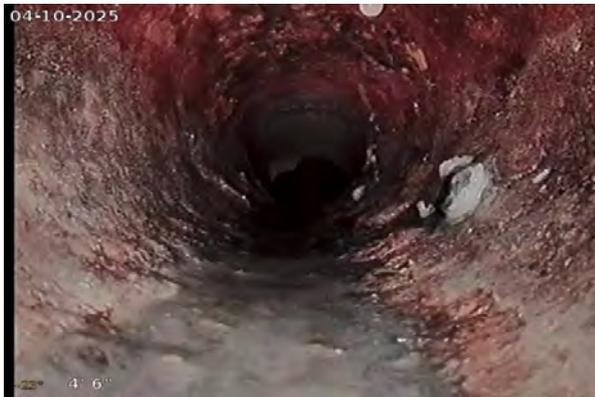
3, 00:00:27, 0.00ft
Deposits Attached Other, 5% of cross sectional area from 12 o'clock to 12 o'clock / DEPOSITS ATTACHED

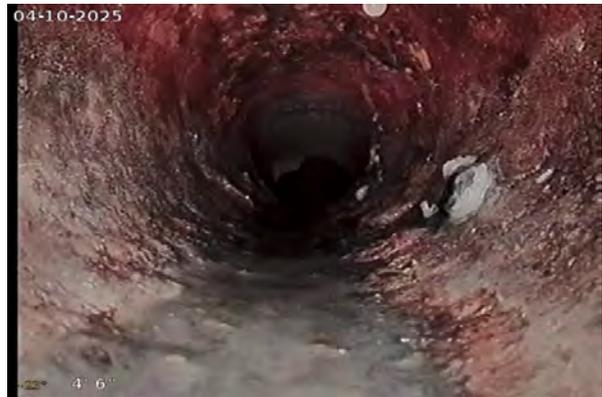
4, 00:00:27, 1.00ft
Deposits Attached Encrustation, 5% of cross sectional area from 12 o'clock to 12 o'clock, Start

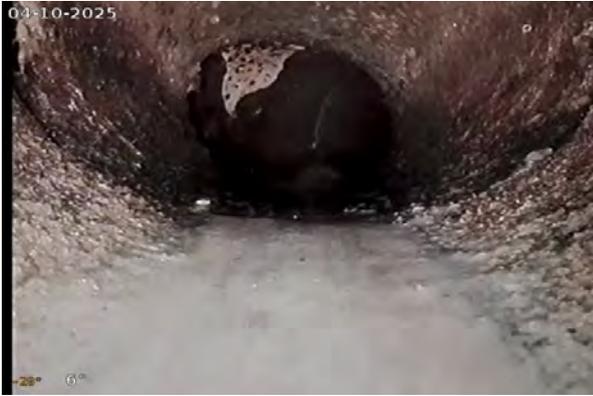
5, 00:00:45, 1.00ft
Line Down, change to: 40%

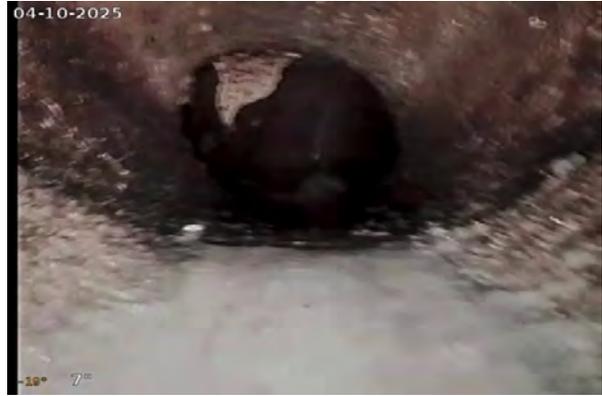
6, 00:00:45, 2.00ft
Deposits Settled Fine, 5% of cross sectional area from 5 o'clock to 7 o'clock, Start

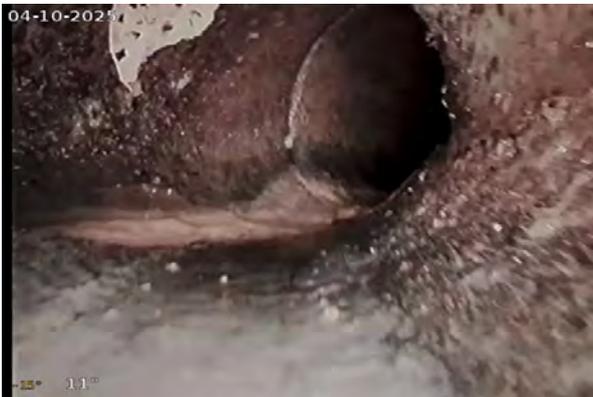
7, 00:00:46, 2.50ft
Tap Factory Made at 9 o'clock, dia/height: 4inch

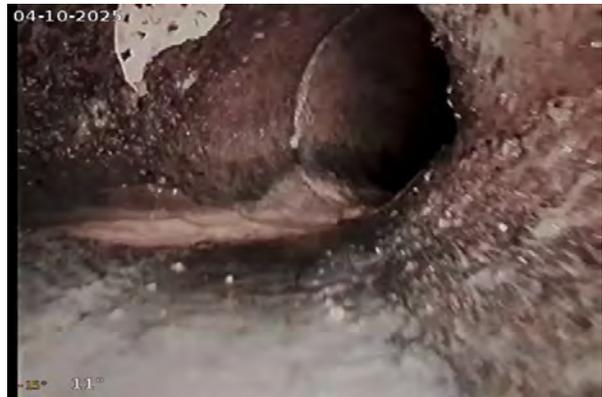
8, 00:00:46, 3.00ft
Line Right Down, change to: 45%

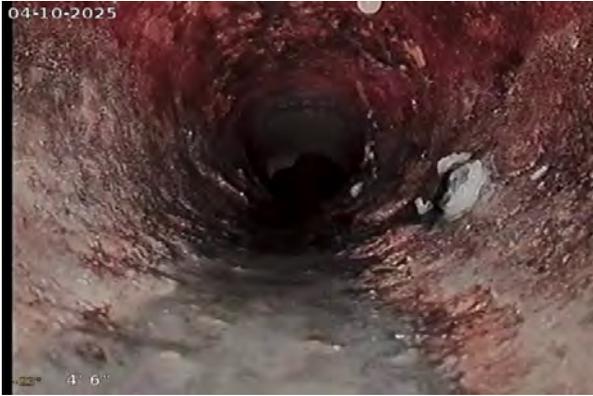
9, 00:00:27, 5.00ft
Deposits Attached Encrustation, 5% of cross sectional area from 12 o'clock to 12 o'clock, Finish

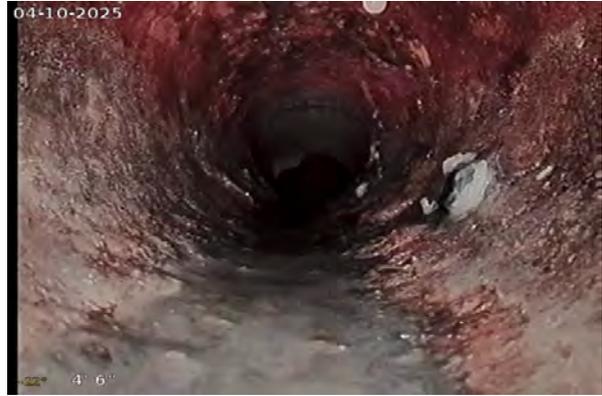
10, 00:00:27, 5.00ft
Deposits Attached Other, 5% of cross sectional area from 12 o'clock to 12 o'clock, Start / DEPOSITS ATTACHED

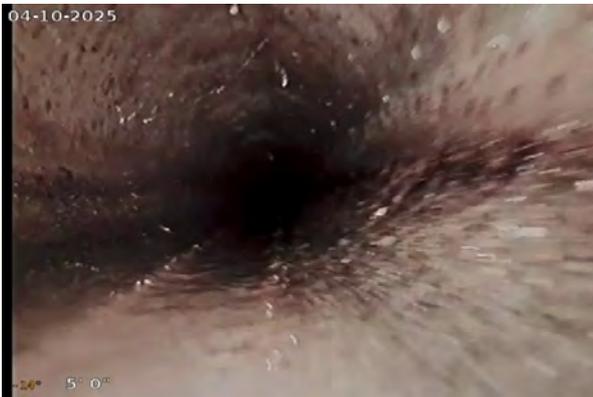
11, 00:00:57, 5.10ft
Deposits Attached Grease, 5% of cross sectional area from 12 o'clock to 12 o'clock, Start

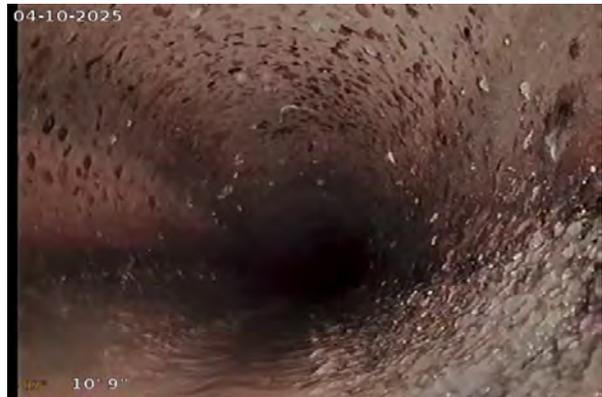
12, 00:01:07, 10.00ft
Line Down, change to: 15%

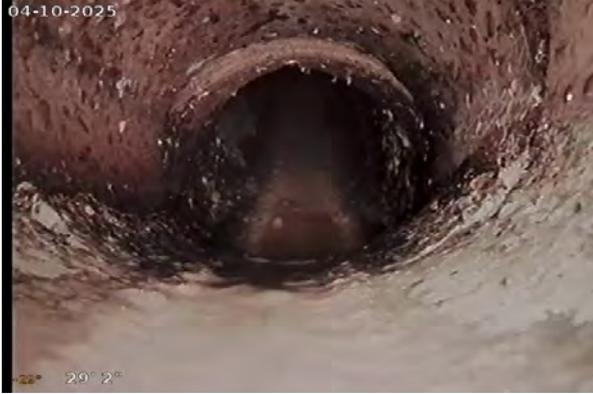
13, 00:01:47, 30.00ft
Line Down, change to: 25%

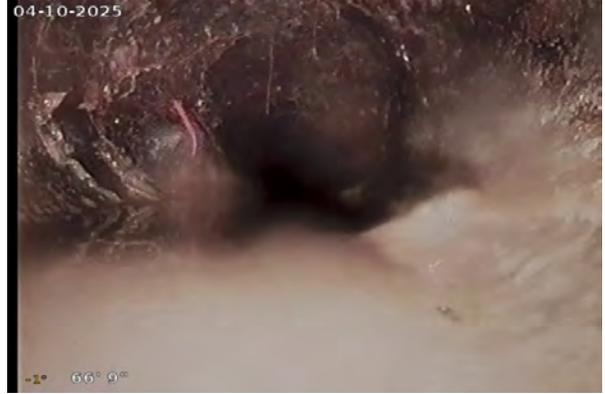
14, 00:03:27, 67.00ft
Roots Fine Joint from 7 o'clock to 5 o'clock, within 8 inch

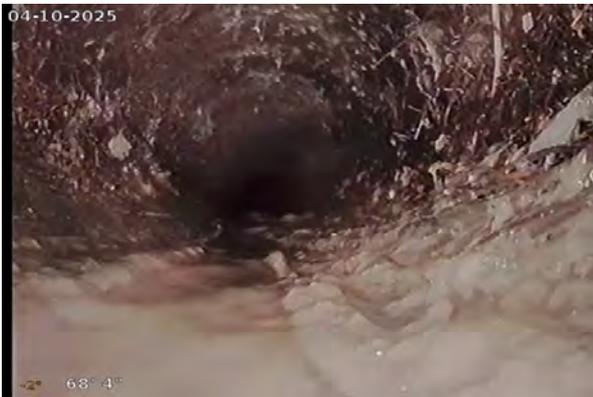
15, 00:03:57, 67.50ft
Deposits Attached Encrustation, 10% of cross sectional area from 12 o'clock to 12 o'clock

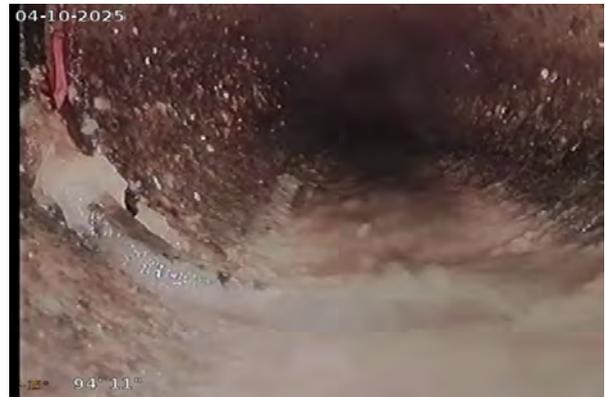
20, 00:04:50, 95.00ft
Roots Fine Joint from 7 o'clock to 9 o'clock, within 8 inch

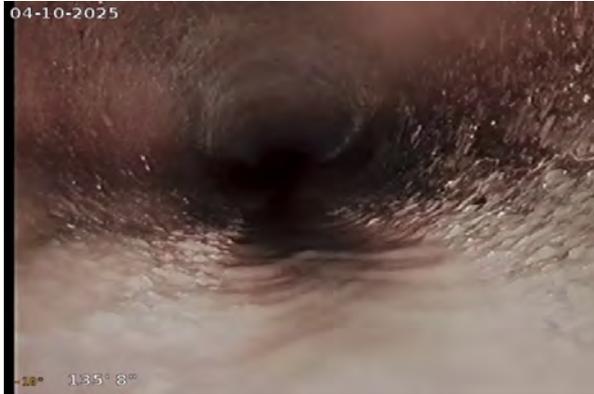
25, 00:06:26, 136.00ft
Deposits Settled Fine, 5% of cross sectional area from 5 o'clock to 7 o'clock, Finish

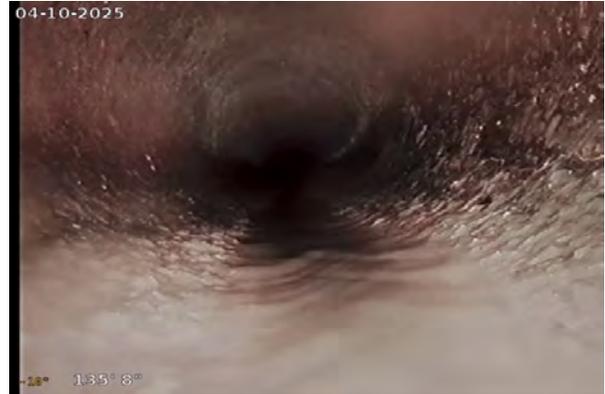
26, 00:06:26, 136.00ft
Deposits Attached Other, 5% of cross sectional area from 12 o'clock to 12 o'clock, Finish / DEPOSITS ATTACHED

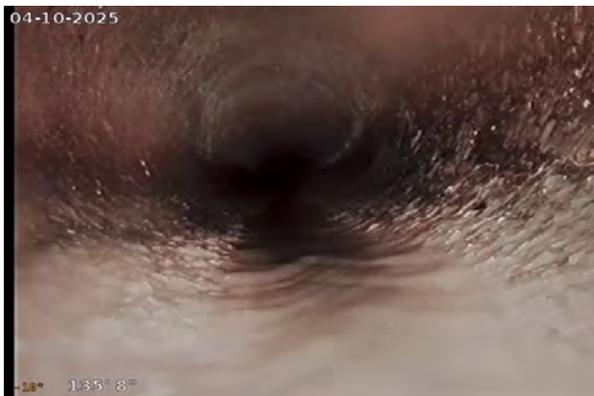
27, 00:06:26, 136.00ft
Deposits Attached Grease, 5% of cross sectional area from 12 o'clock to 12 o'clock, Finish

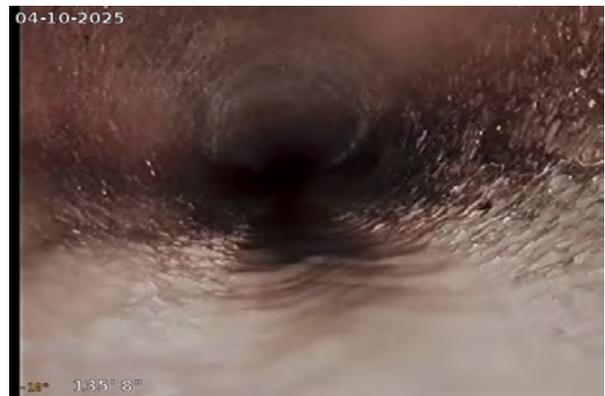
28, 00:06:26, 136.00ft
Miscellaneous Survey Abandoned / CANNOT PUSH CAMERA FURTHER

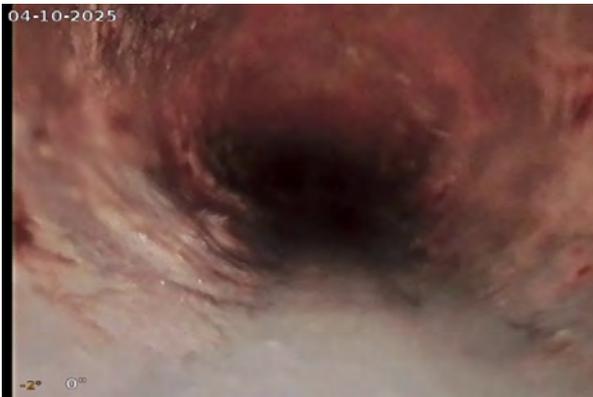
3, 00:00:29, 1.00ft
Deposits Attached Encrustation, 5% of cross sectional area from 12 o'clock to 12 o'clock

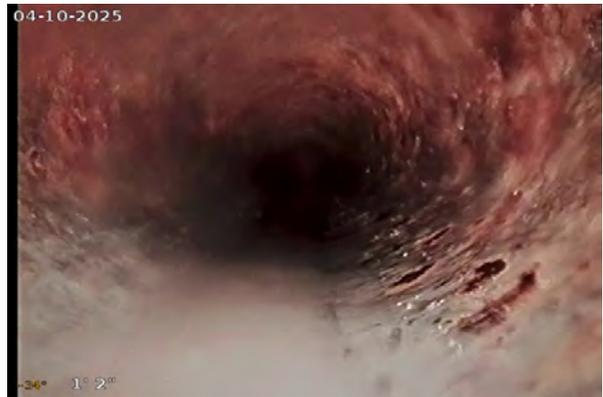
4, 00:00:33, 1.20ft
Deposits Settled Fine, 5% of cross sectional area from 5 o'clock to 7 o'clock, Start

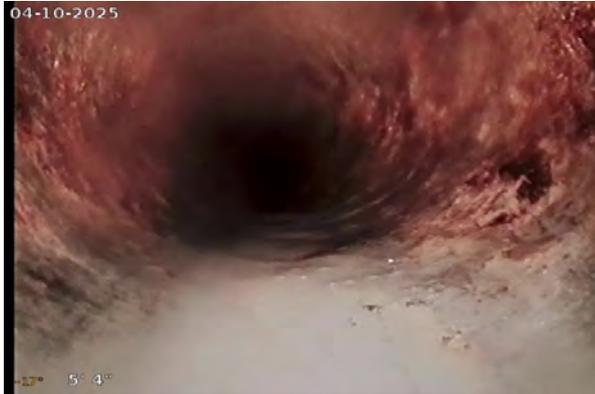
5, 00:01:02, 2.00ft
Deposits Attached Other, 5% of cross sectional area from 12 o'clock to 12 o'clock, Start / DEPOSITS ATTACHED

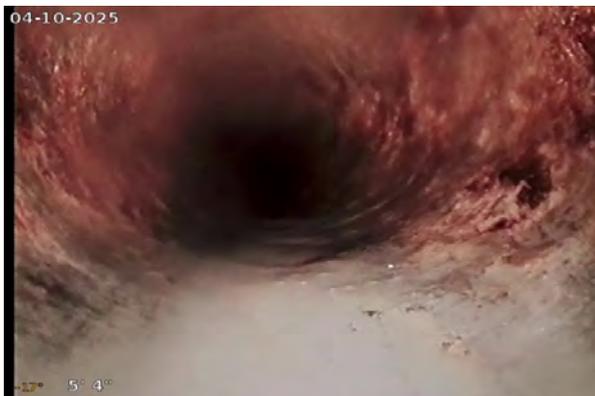
7, 00:01:02, 5.00ft
Deposits Attached Grease, 5% of cross sectional area from 5 o'clock to 7 o'clock, Start

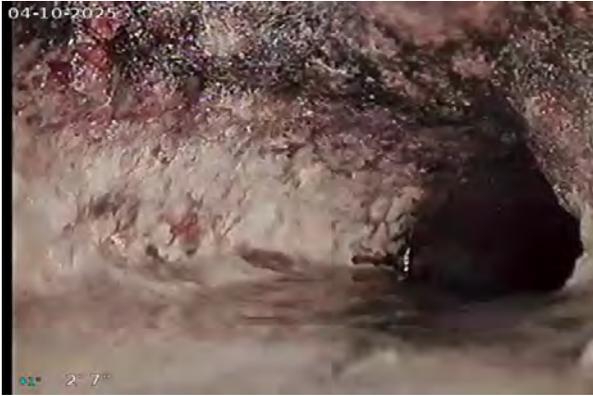
5, 00:00:41, 3.10ft
Deposits Attached Grease, 10% of cross sectional area from 12 o'clock to 12 o'clock

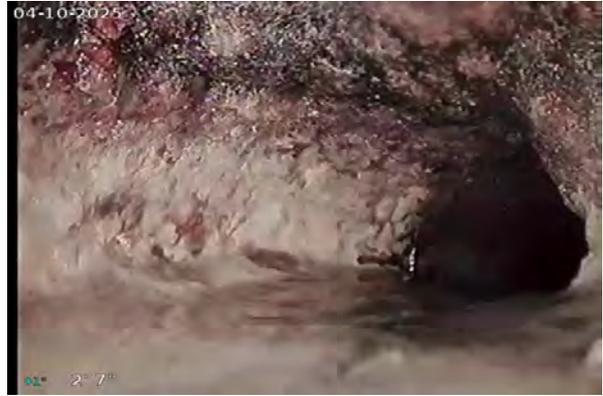
6, 00:00:41, 3.20ft
Deposits Attached Other, 5% of cross sectional area from 12 o'clock to 12 o'clock / DEPOSITS ATTACHED

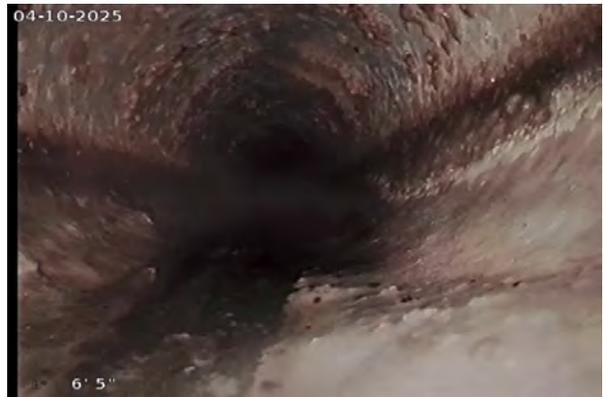
8, 00:00:48, 6.50ft
Deposits Attached Grease, 5% of cross sectional area from 12 o'clock to 12 o'clock, Start

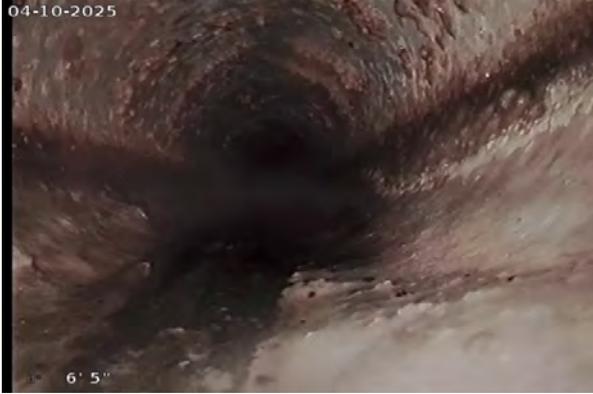
9, 00:00:48, 6.60ft
Deposits Attached Other, 5% of cross sectional area from 12 o'clock to 12 o'clock, Start / DEPOSITS ATTACHED

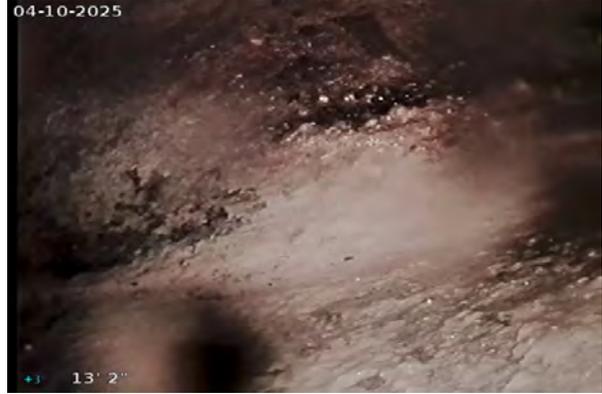
10, 00:01:09, 13.50ft
Deposits Attached Grease, 5% of cross sectional area from 12 o'clock to 12 o'clock, Finish

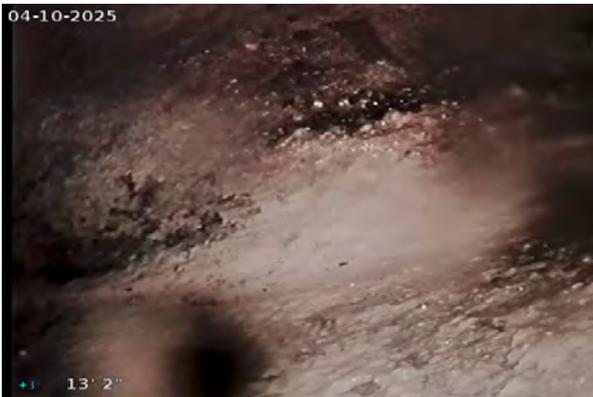
11, 00:01:09, 13.50ft
Deposits Attached Other, 5% of cross sectional area from 12 o'clock to 12 o'clock, Finish / DEPOSITS ATTACHED

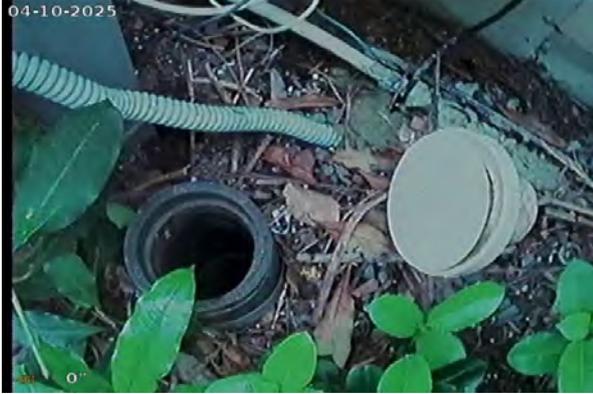
1, 00:00:00, 0.00ft
Cleanout House / SCO8 C009

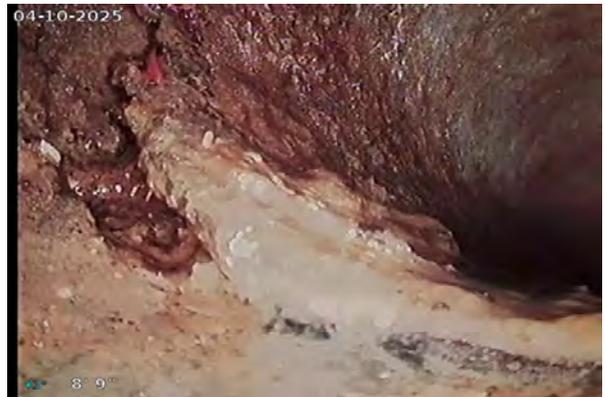
4, 00:00:27, 8.00ft
Miscellaneous Camera Underwater, Finish

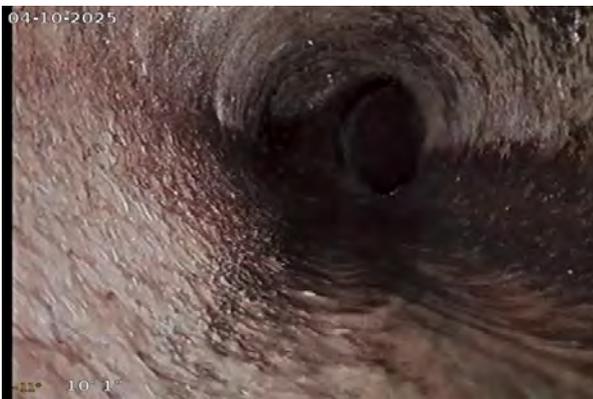
7, 00:00:39, 10.00ft
Deposits Settled Fine, 5% of cross sectional area from 5 o'clock to 7 o'clock, Start

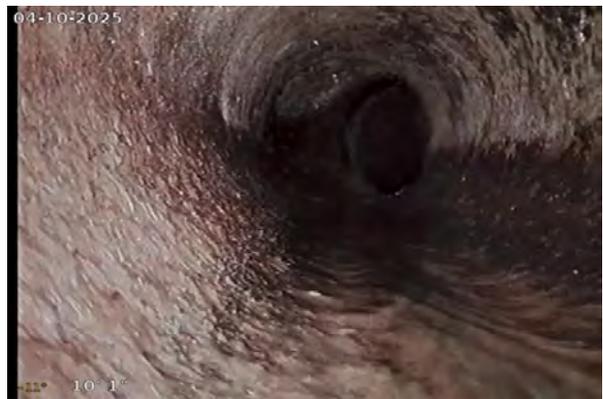
8, 00:00:39, 10.10ft
Deposits Attached Other, 5% of cross sectional area from 12 o'clock to 12 o'clock, Start / DEPOSITS ATTACHED

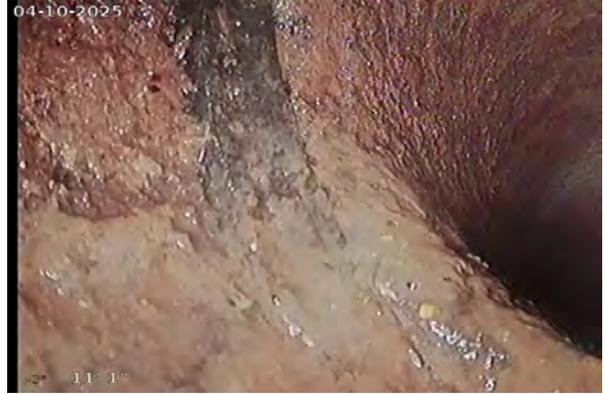
10, 00:00:45, 11.00ft
 Deposits Attached Grease, 5% of cross sectional area from 4 o'clock to 8 o'clock, Start

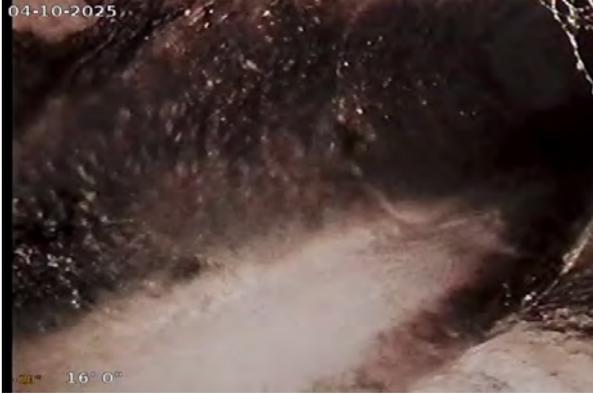
13, 00:01:04, 16.00ft
Miscellaneous Shape or Size Change, dia/height: 8inch / 4 INCH TO 8 INCH
