PROPERTY CONDITION REPORT

Marin Valley Mobile Country Club

100 Marin Valley Drive
Novato, California 94949

June 10, 2025

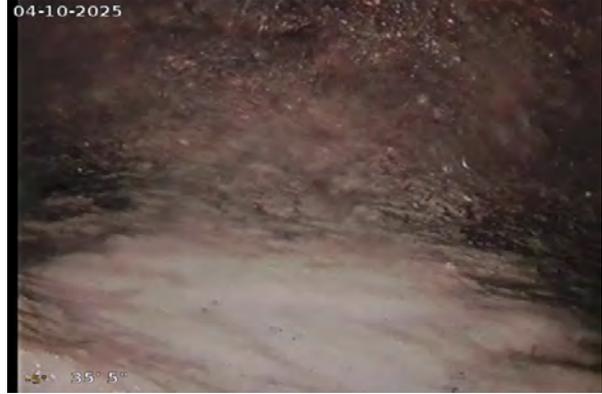
14, 00:01:35, 35.50ft
Deposits Settled Fine, 5% of cross sectional area from 5 o'clock to 7 o'clock, Finish

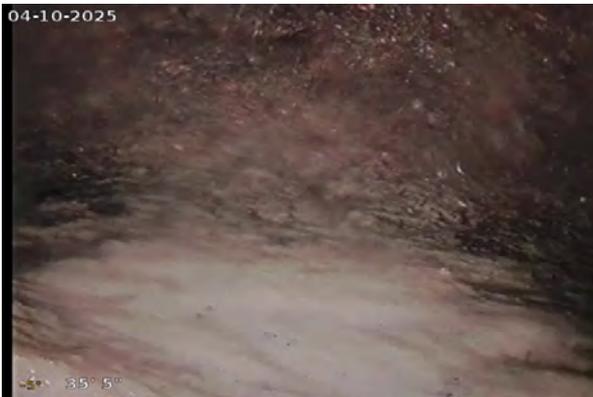
15, 00:01:35, 35.50ft
Deposits Attached Other, 5% of cross sectional area from 12 o'clock to 12 o'clock, Finish / DEPOSITS ATTACHED

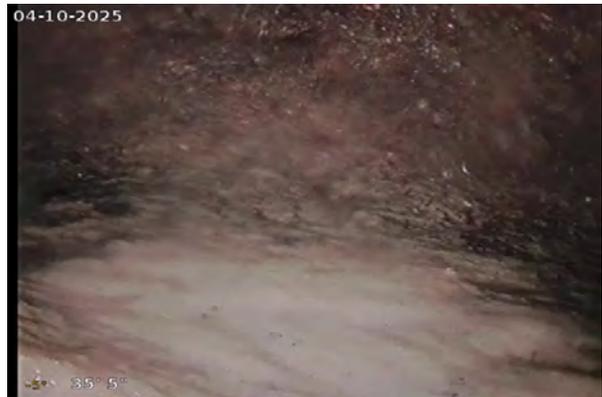
16, 00:01:35, 35.50ft
Deposits Attached Grease, 5% of cross sectional area from 4 o'clock to 8 o'clock, Finish

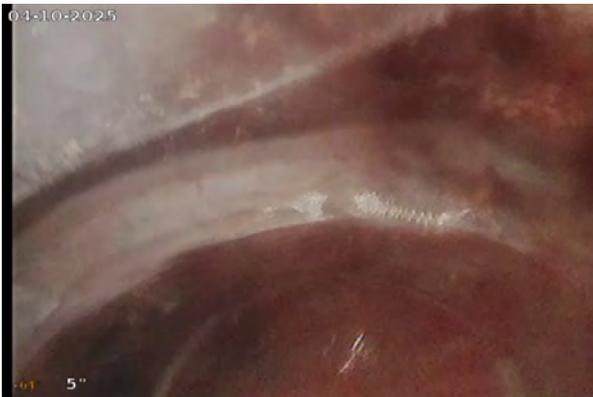
3, 00:00:47, 1.00ft
Miscellaneous Survey Abandoned / CAMERA COULD NOT MAKE IT PAST THE 90 DEGREE BENDS WITHIN THE PIPELINE.

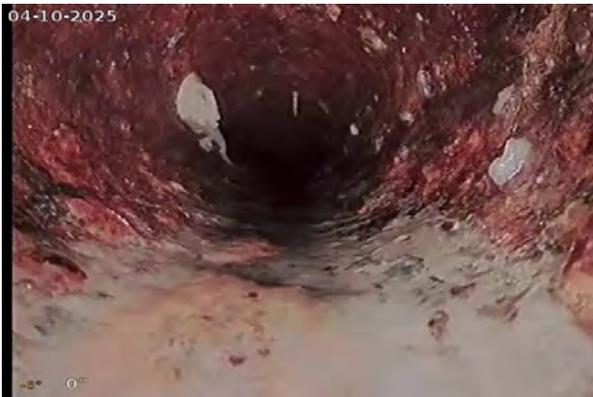
3, 00:00:23, 1.00ft
Deposits Attached Encrustation, 5% of cross sectional area from 12 o'clock to 12 o'clock, Start

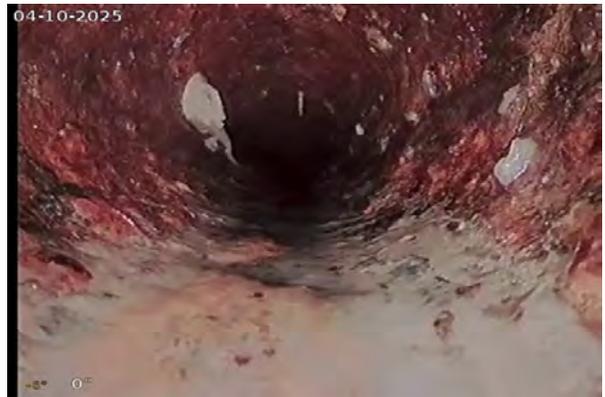
4, 00:00:23, 1.10ft
Deposits Attached Grease, 5% of cross sectional area from 5 o'clock to 7 o'clock, Start

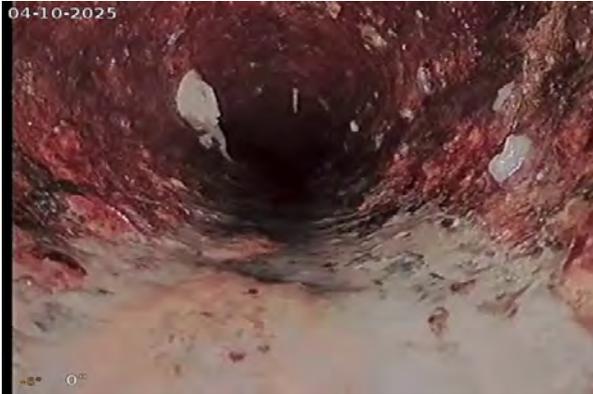
5, 00:00:23, 1.20ft
Deposits Attached Other, 5% of cross sectional area from 12 o'clock to 12 o'clock, Start / DEPOSITS ATTACHED

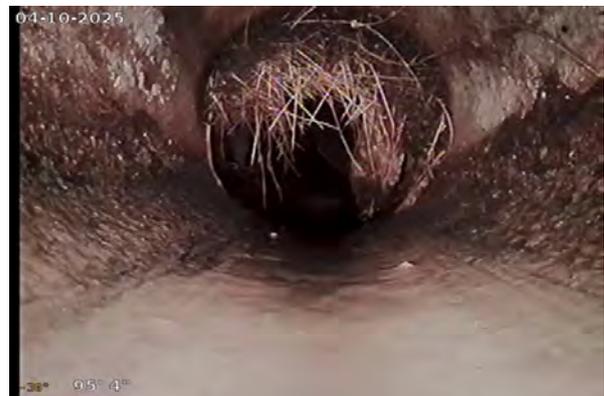
12, 00:03:46, 96.00ft
Roots Ball Joint from 9 o'clock to 5 o'clock, 55% of cross sectional area, within 8 inch

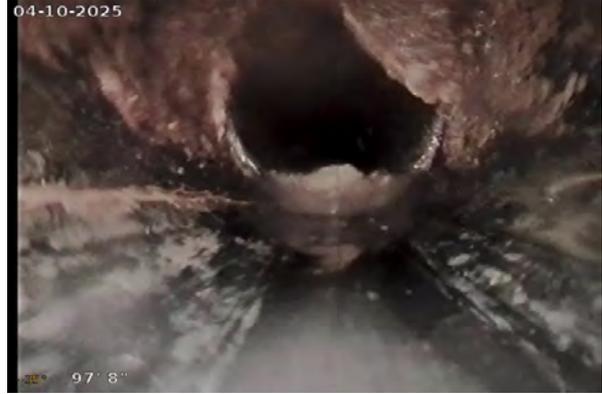
14, 00:04:11, 98.00ft
Deposits Attached Other, 25% of cross sectional area from 12 o'clock to 3 o'clock / UNKNOWN DEPOSIT ATTACHED

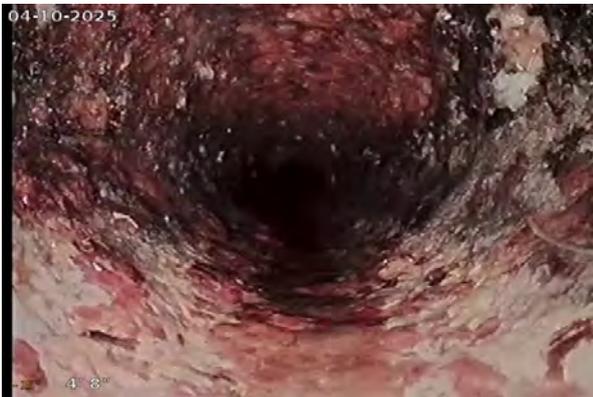
3, 00:00:17, 0.00ft
Deposits Attached Grease, 10% of cross sectional area from 12 o'clock to 12 o'clock

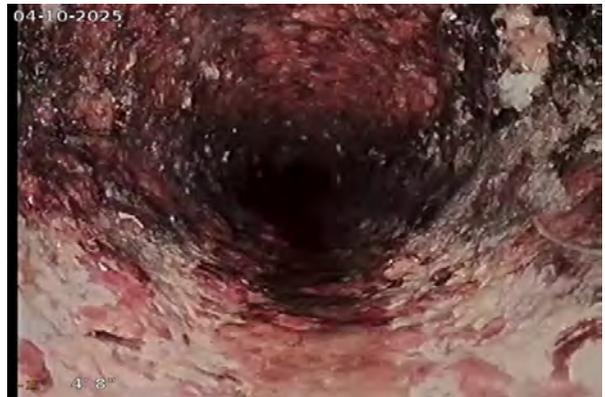
4, 00:00:17, 0.00ft
Deposits Attached Encrustation, 10% of cross sectional area from 12 o'clock to 12 o'clock

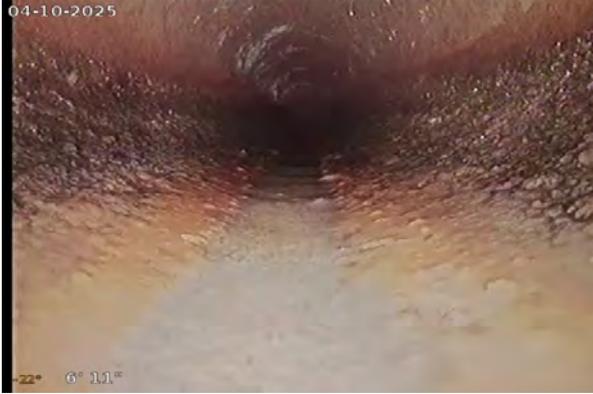
5, 00:00:26, 1.00ft
Deposits Settled Fine, 5% of cross sectional area from 5 o'clock to 7 o'clock, Start

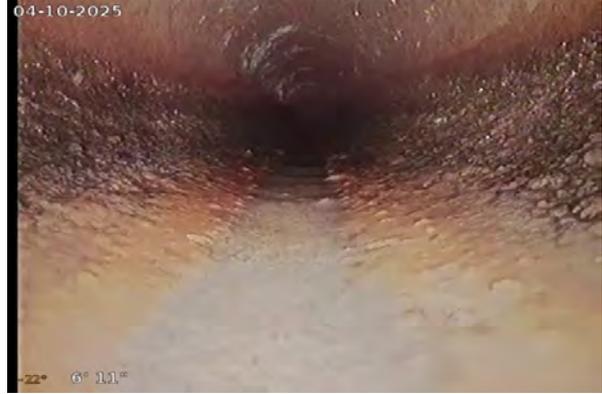
6, 00:00:26, 1.10ft
Deposits Attached Grease, 5% of cross sectional area from 12 o'clock to 12 o'clock

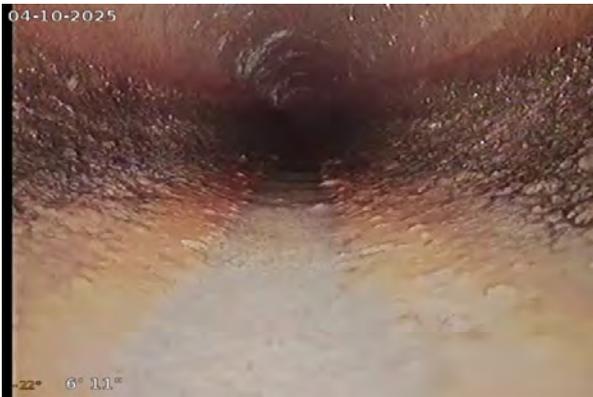
7, 00:00:26, 1.20ft
Deposits Attached Other, 5% of cross sectional area from 12 o'clock to 12 o'clock, Start / DEPOSITS ATTACHED

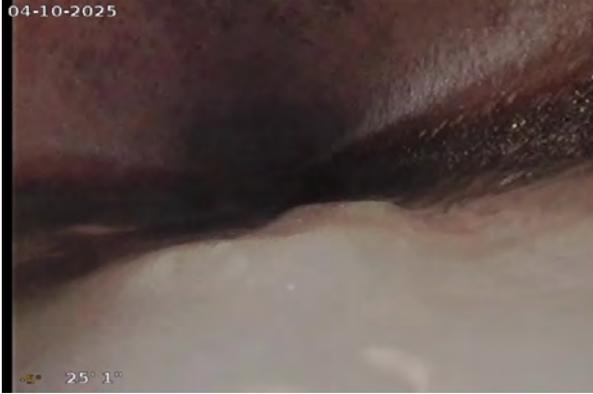
17, 00:01:34, 55.00ft
Deposits Attached Other, 5% of cross sectional area from 8 o'clock to 4 o'clock, Start / DEPOSITS ATTACHED

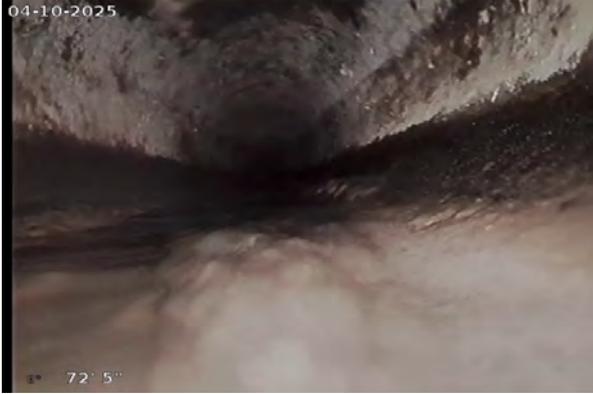
25, 00:02:40, 96.00ft
Deposits Attached Other, 5% of cross sectional area from 12 o'clock to 12 o'clock / DEPOSITS ATTACHED

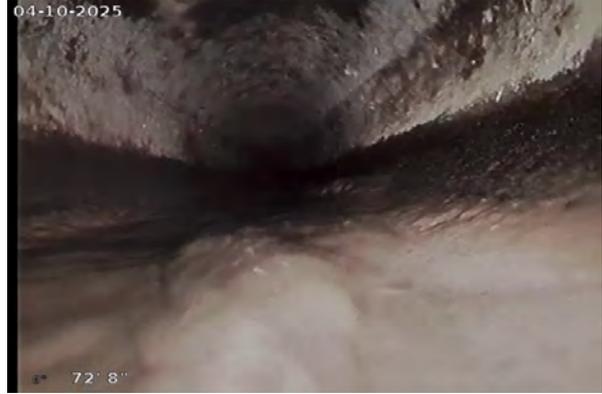
26, 00:02:40, 96.00ft
Deposits Attached Grease, 10% of cross sectional area from 5 o'clock to 7 o'clock, Start

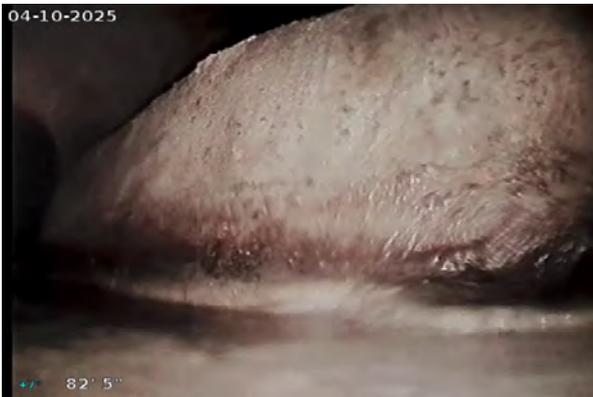
27, 00:03:00, 102.50ft
Deposits Attached Grease, 10% of cross sectional area from 5 o'clock to 7 o'clock, Finish
